Investigation of wind turbine gearbox bearing subsurface damage considering transient loading and the separation of MnS inclusions

Wind turbine bearing failure

Destructive investigation of a failed bearing

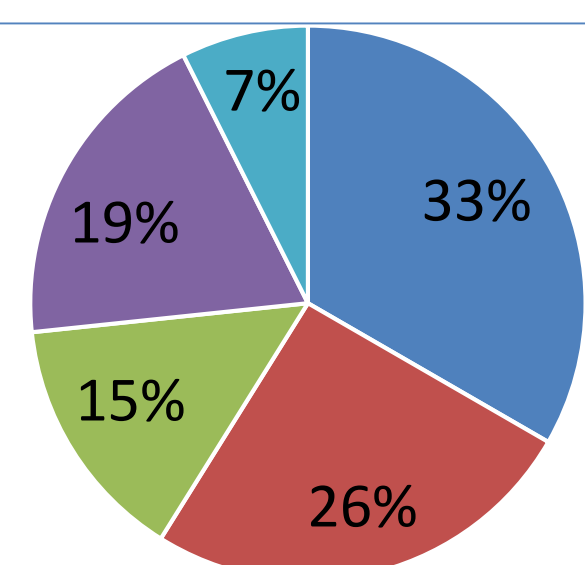
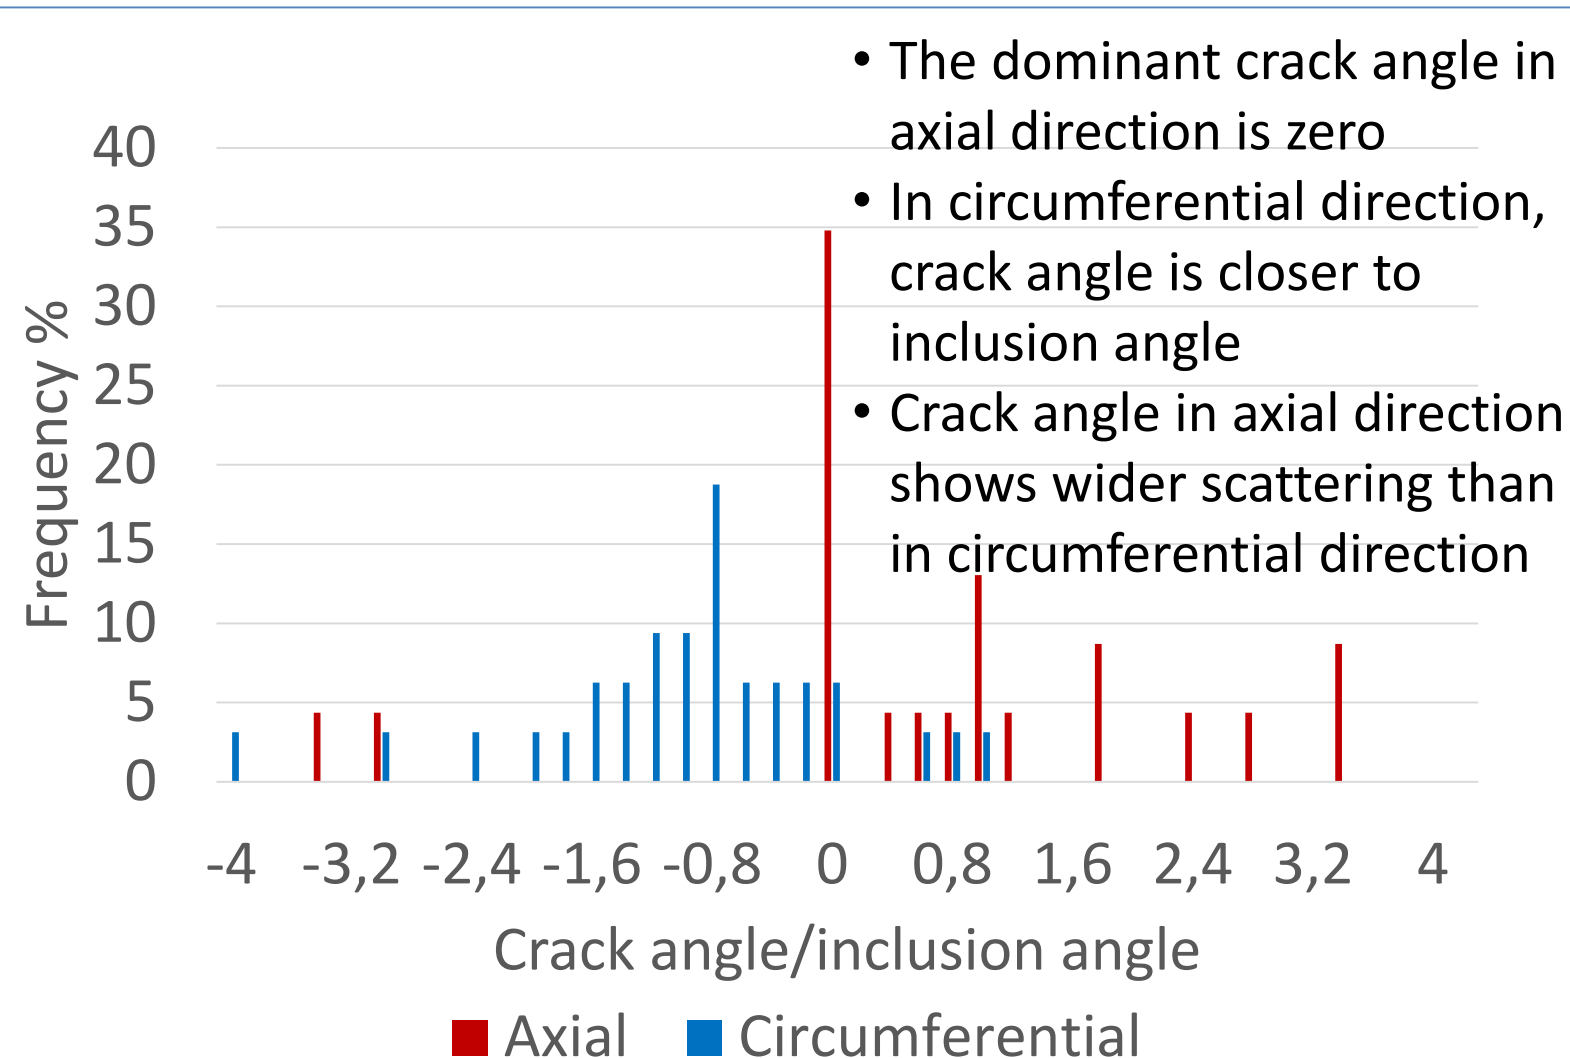
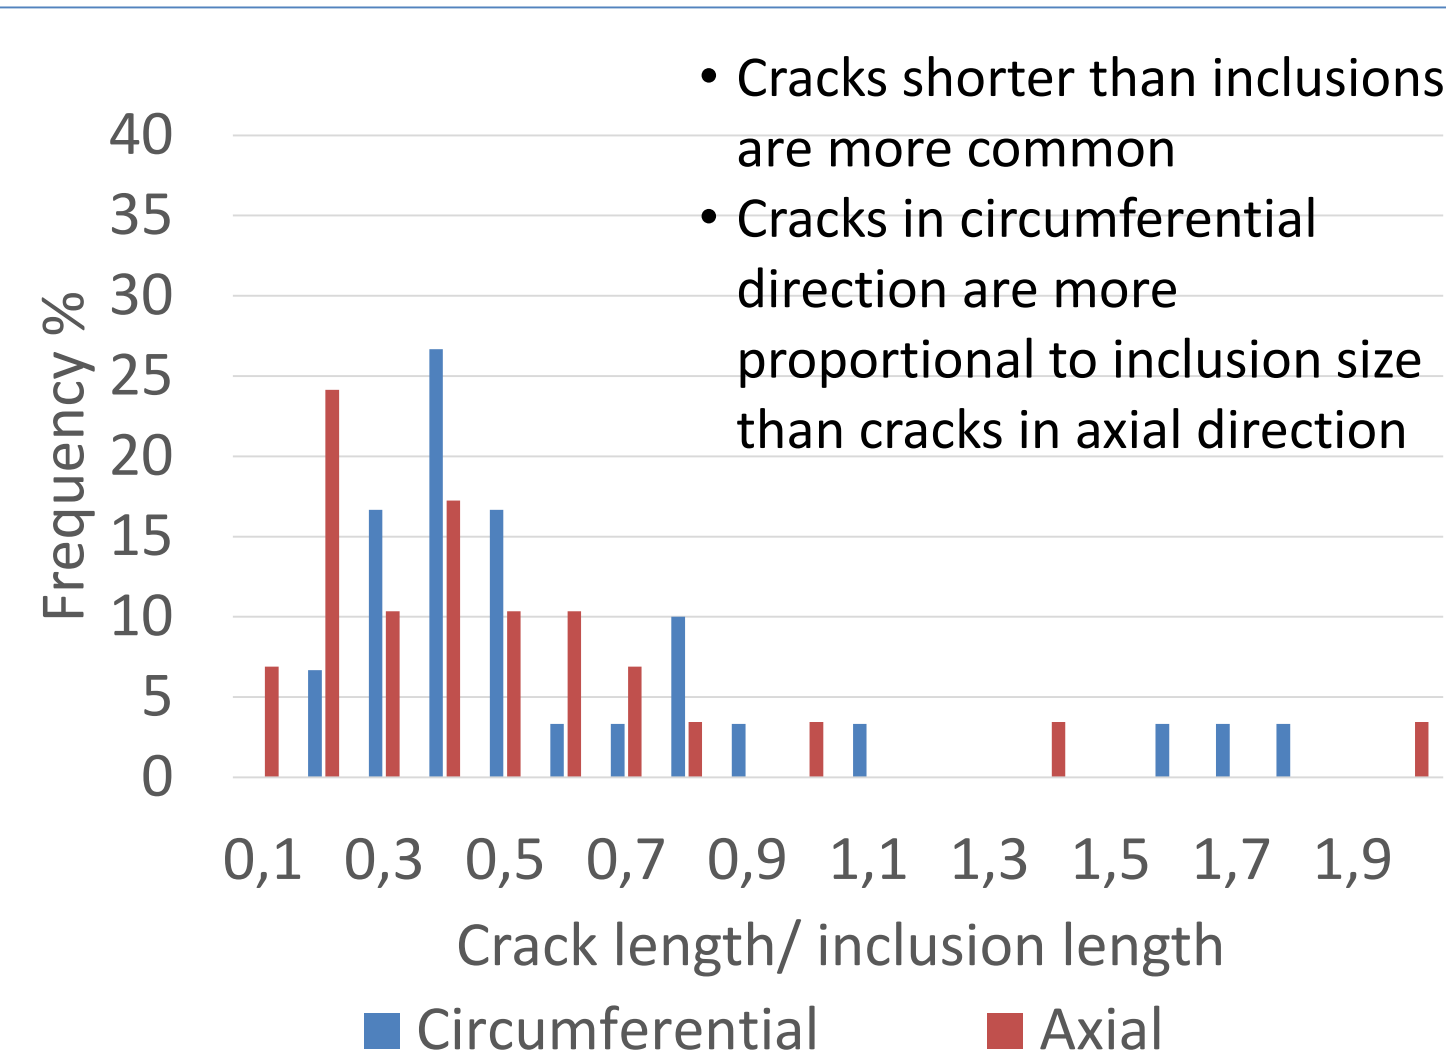
The following observed features or MnS inclusions are related to the subsurface damage

- Undamaged inclusions
- Inclusions separated from the steel matrix by gap(s)
- Cracked inclusions
- Cracks initiate from inclusions into the steel matrix
- Butterflies which are the WEA attached to inclusions

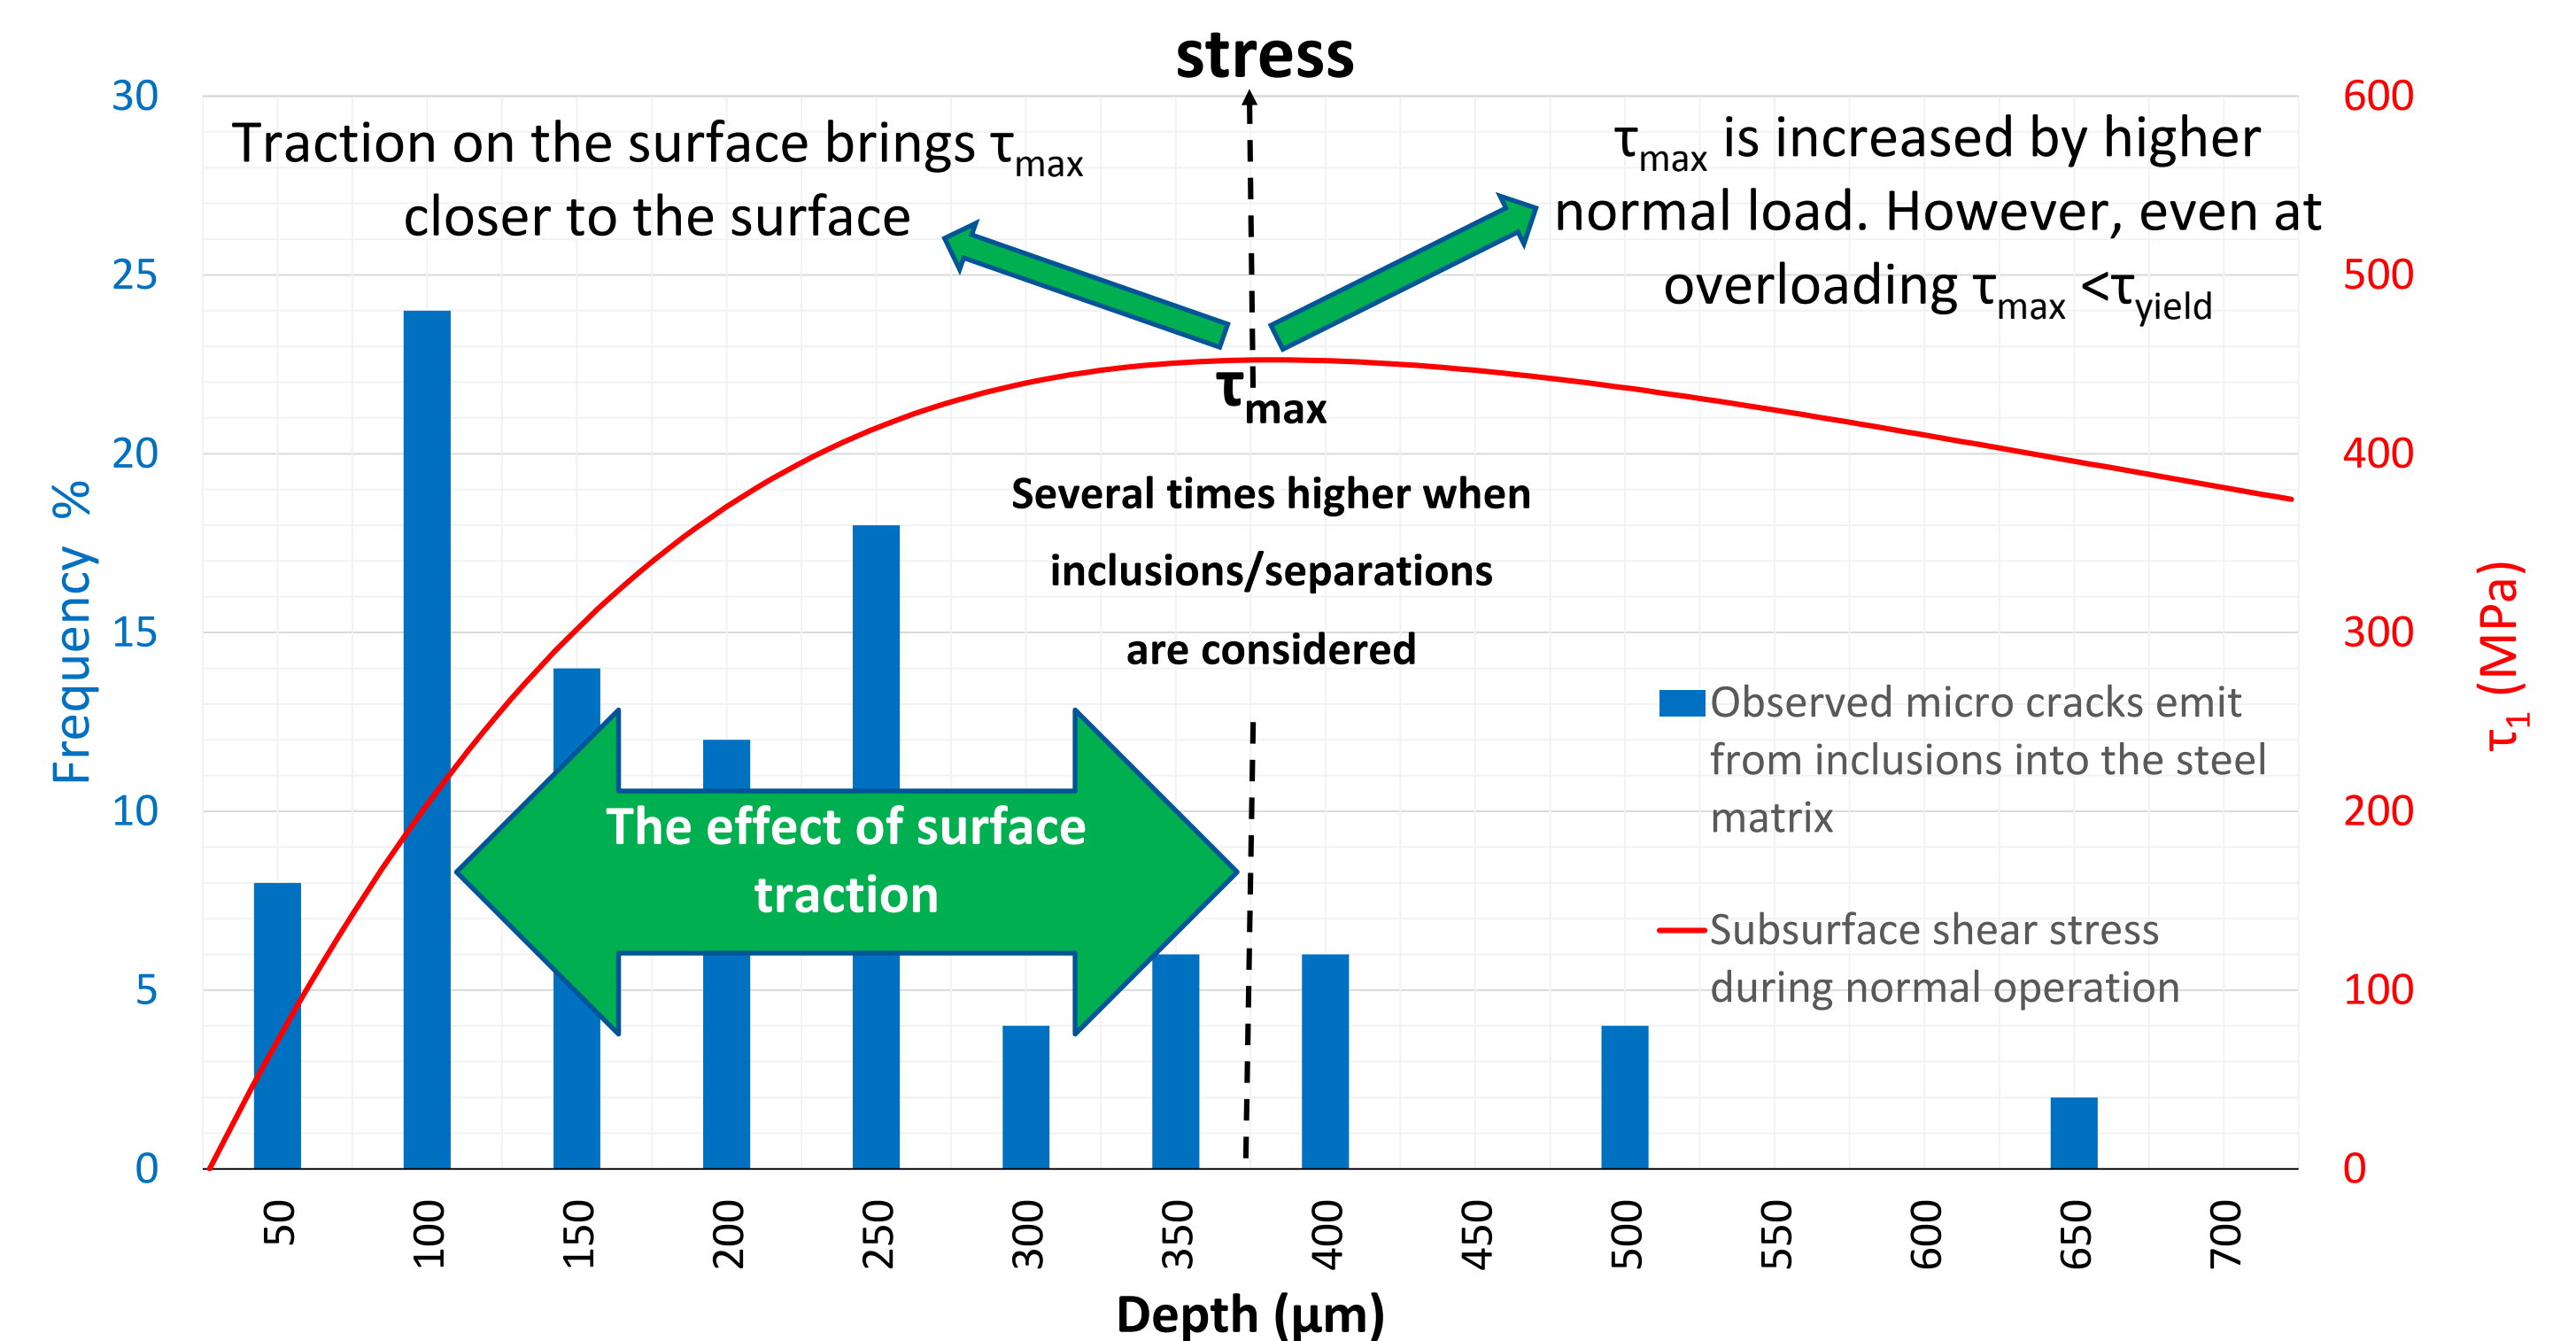
Depth of micro cracks and the distribution of subsurface shear stress

- The observed types of damages: inclusions separated from the matrix by gaps; internal micro cracks of the inclusions; micro cracks initiate from inclusions into the steel matrix; WEA around the inclusion (Butterflies).
- Without considering the effect of inclusions or gaps, overloading could not cause subsurface yielding.
- The effect of high surface traction can be seen clearly by comparing the dominating depth of the subsurface micro cracks with the depth of the maximum shear stress.
