# Investigation of wind turbine gearbox bearing subsurface damage considering transient loading

In this study, a failed bearing in planetary gear stage of a sub megawatt wind turbine gearbox is destructively investigated to identify different stages and features of the premature damages induced. The focus is on the role of Manganese Sulphide (MnS) inclusion in subsurface initiated damage of White Etching Areas (WEAs) and White Etching Cracks (WECs). The main types are grouped as (1) undamaged MnS inclusions; (2) inclusions separated from the matrix by gaps; (3) internal micro cracks of the inclusions; (4) micro cracks initiated from inclusions into the steel matrix; and (5) WEA around the inclusion (Butterflies). Alongside this work, the load, maximum contact pressure and subsurface stresses are calculated for the planetary bearing of NREL (National Renewable Energy Laboratory) 750 kW wind turbine during three operational conditions: shutdown, start up and normal operation. The high subsurface stress levels due to transient loading and the stress concentration around the MnS inclusion are correlated to the yielding of the material. The depth of the maximum shear stress is correlat

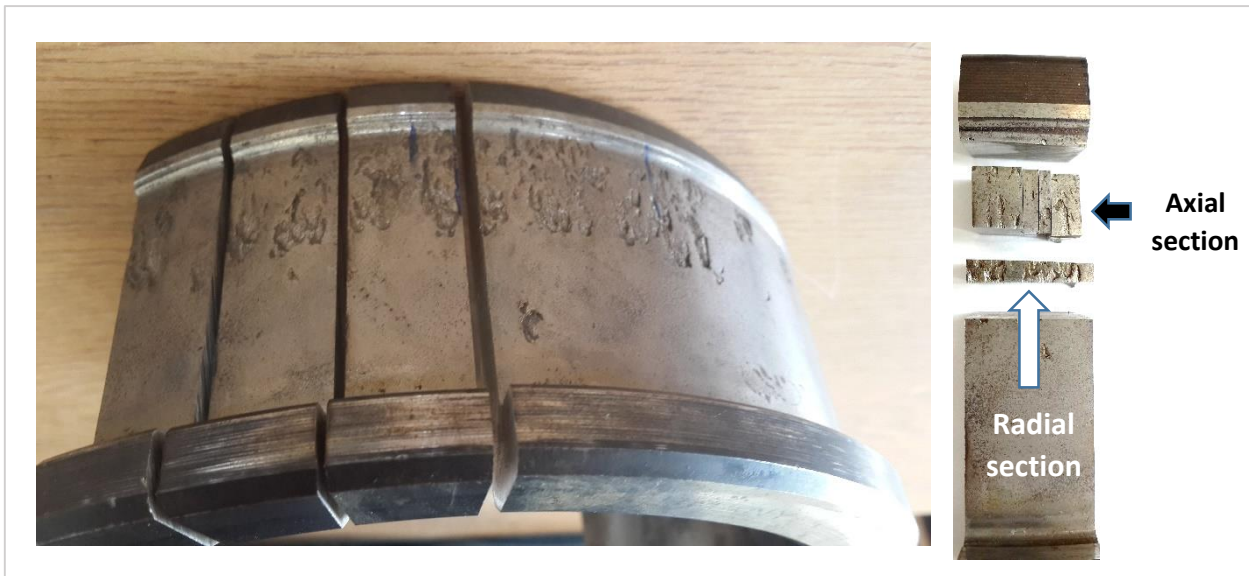
The investigated bearing was used in a planetary stage of a sub megawatt wind turbine. The visual observation showed extreme surface damage in the inner race comparing to the outer race. The inner race is destructively investigated by preparing samples for microscopic examination. The first step in sample preparation is to section the inner race to smaller parts where the subsurface of radial and axial sections can be examined. Figure 1 shows the sectioning pattern adopted. A variety of sections from different locations of the bearing has been created such as the severely damaged surface, the lightly damaged surface and the visually non damaged surface. After the grinding and polishing up to the mirror like surface, the samples have been etched with nital. The microscopic examination of the subsurface area covered more than 1 mm depth from the surface. Because the structure of the WEA differs from the non-altered area, these WEA will appear in a lighter colour under optical microscopy. Etching is important to reveal the microstructure alternation such as WEA and WECs but it is not recommended to reveal other features such as the separation of the inclusion from the steel matrix. Although most of the images analysed have been acquired by using optical microscopy, images of more detailed microstructure features have been acquired using Scanning Electron Microscopy (SEM) which reveal the size and the topography of the WEA as well as the size and the directions of the micro cracks inside the inclusion and the matrix. Further characterization of the separation of the inclusions from the matrix and the chemical elements of the inclusions is carried out using the Energy Dispersive Spectroscopy (EDS). Also, the Atomic Force Microscopy (AFM) is utilized to show clearly the gaps or separation attached to the MnS inclusion, as well as the micro cracks.

Figure 1: Main sections and subsections of the failed bearing

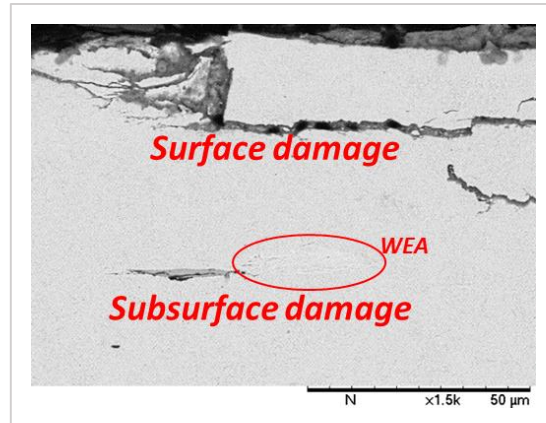
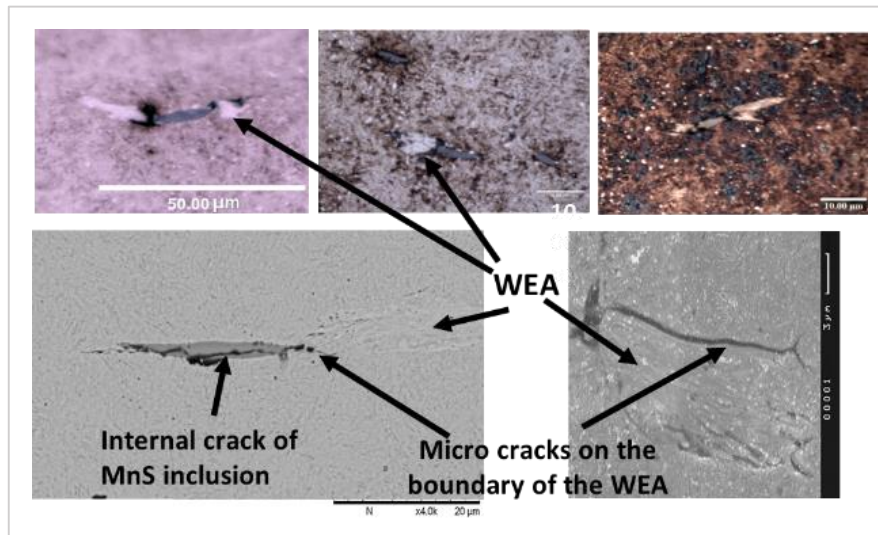
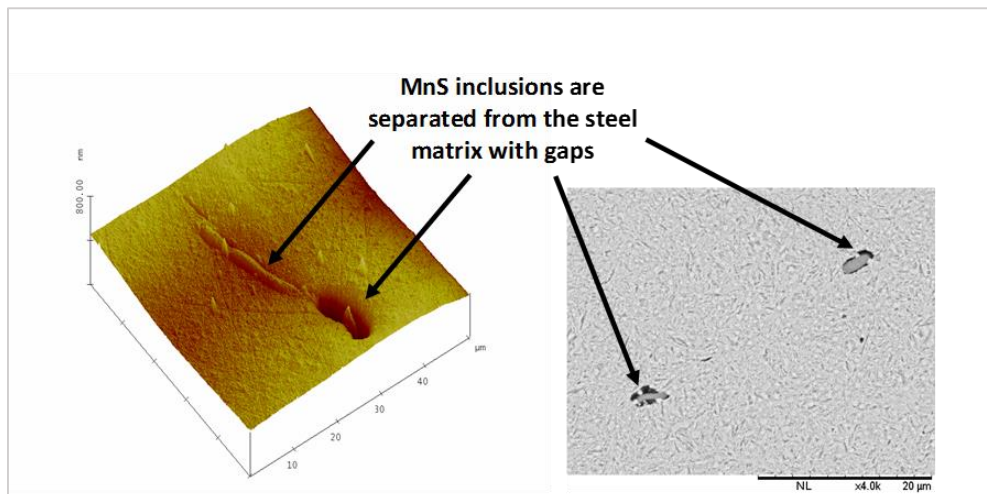
The observed damages vary between surface and subsurface as shown in Figure 2 (a). The failures may initiate either on the surface or near the surface of contact in the bearing raceways. In this study, the examination is focused on the subsurface initiated damage at the MnS inclusions and the surrounding steel matrix which are marked in Figure 2 (b) and (c). The observations are classified into five types which are undamaged inclusions, inclusions separate from the matrix by gap(s), internal cracks of the inclusions, cracks initiate from inclusions into the steel matrix, WEA around the inclusion (Butterflies). Statistical study associated with each specified damage type is carried out. Figure 3 shows the percentage of each of the observed damage types out of more than 200 MnS inclusions. Figure 4 (a) and (b) show some of the characteristics of the micro cracks associated with MnS inclusions. It can be seen

Figure2: Surface and subsurface damages in the failed wind turbine bearing

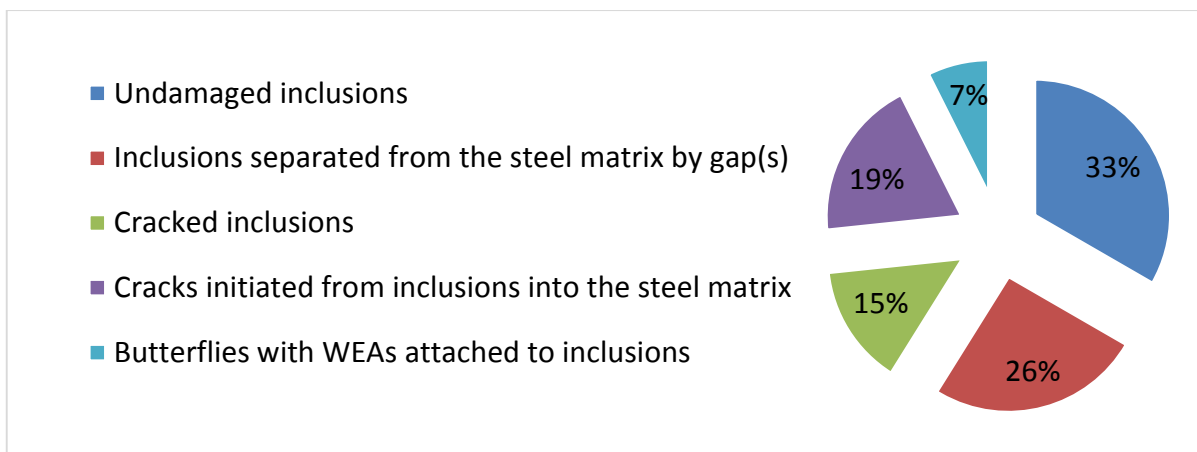
Figure3: Observed subsurface damage types at MnS inclusions

The distractive investigation of a wind turbine bearing failed prematurely provided insight to the subsurface initiated damage at the MnS inclusion. In addition to the surface damage of pitting, spalling and wide and shallow cracks initiated on the surface, four types of subsurface damage are observed which are expected to be the reason for the bigger spalls and the faster deterioration of the bearing life. These are inclusions separated from the matrix by gaps; internal micro cracks of the inclusions; micro cracks initiate from inclusions into the steel matrix; WEA around the inclusion (Butterflies). The analysis of these observations helps drawing up the following conclusions.

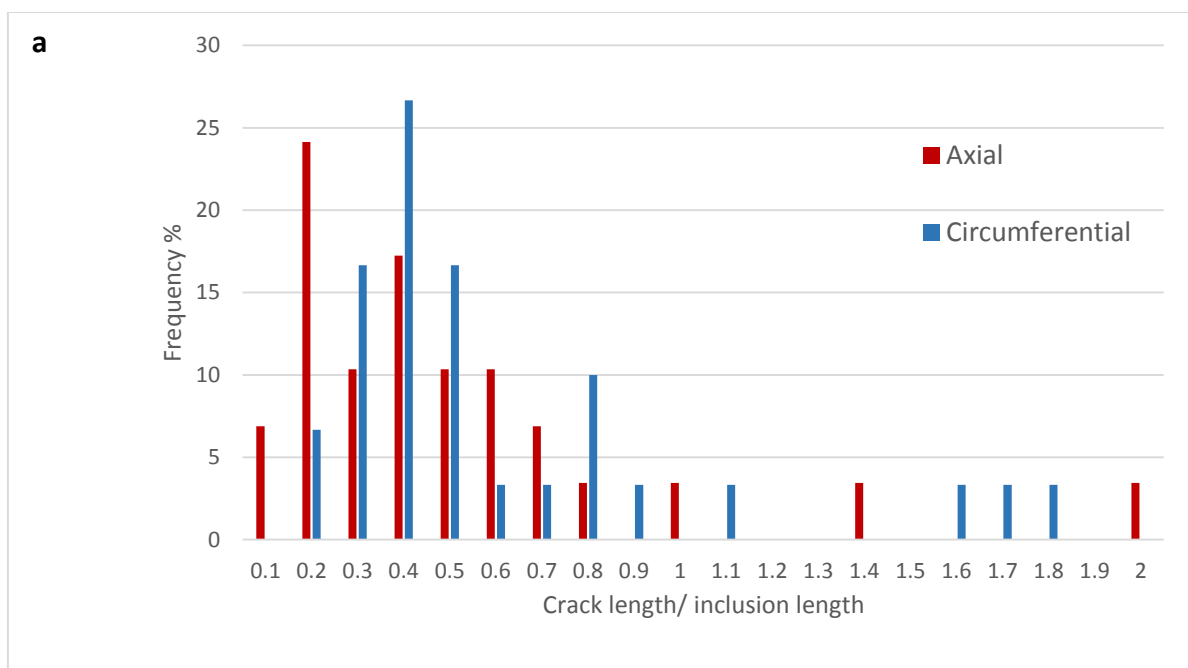
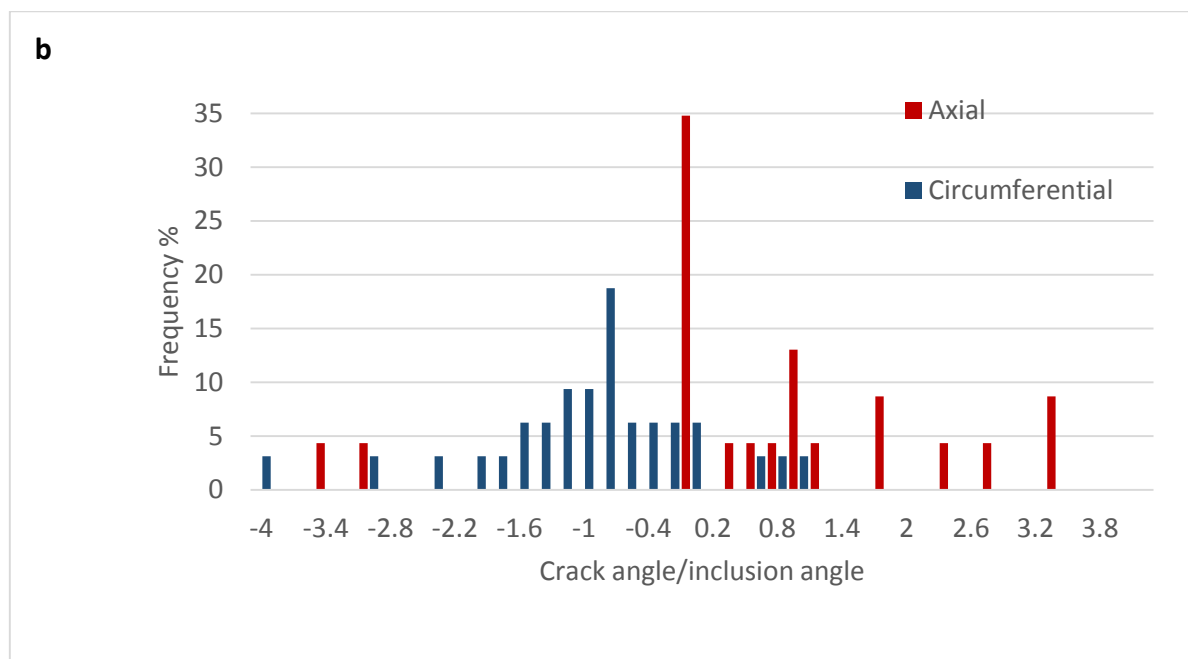
that the dominant crack angle in the axially sectioned samples is almost zero and in circumferentially sectioned samples is closer to the inclusion angle. Also, cracks in circumferentially sectioned samples are more proportional to the inclusion size than cracks in the axially sectioned samples. The investigation on the MnS inclusion in the literature is less reported than the harder inclusions such as  $Al_2O_3$  because it is assumed that the MnS inclusion always deforms without causing gaps attached to it. However, in this study, the results of the AFM, Figure 2 (c), shows that this is not always the case. Because the MnS inclusion separation from the matrix occurred at different depths to the contact surface, sometimes far from the loaded zone, it could be considered that the material defect is caused by the different coefficient of thermal expansion [20]. However, other types of separation could be caused by impact loading [28]. The non-perfect bonding and separation of the MnS inclusions result in high stress concentration around the inclusions [29]. WEA is a microstructure alternation which is expected to occur at the location of high stress concentration, eventually causing the material yielding. This explains their irregular shapes which differ from the flat or steep White Bands (WB) occurred due to the RCF. This also explains the association of high percentage of the observed WEA, butterflies, with the separated inclusions. Another interesting observation is the internal cracking of MnS inclusions. It is found that inclusion cracking could be accompanying by other types of subsurface damages.

Figure 4: Damage characteristics (a) relative micro cracks length (b) relative micro cracks angle

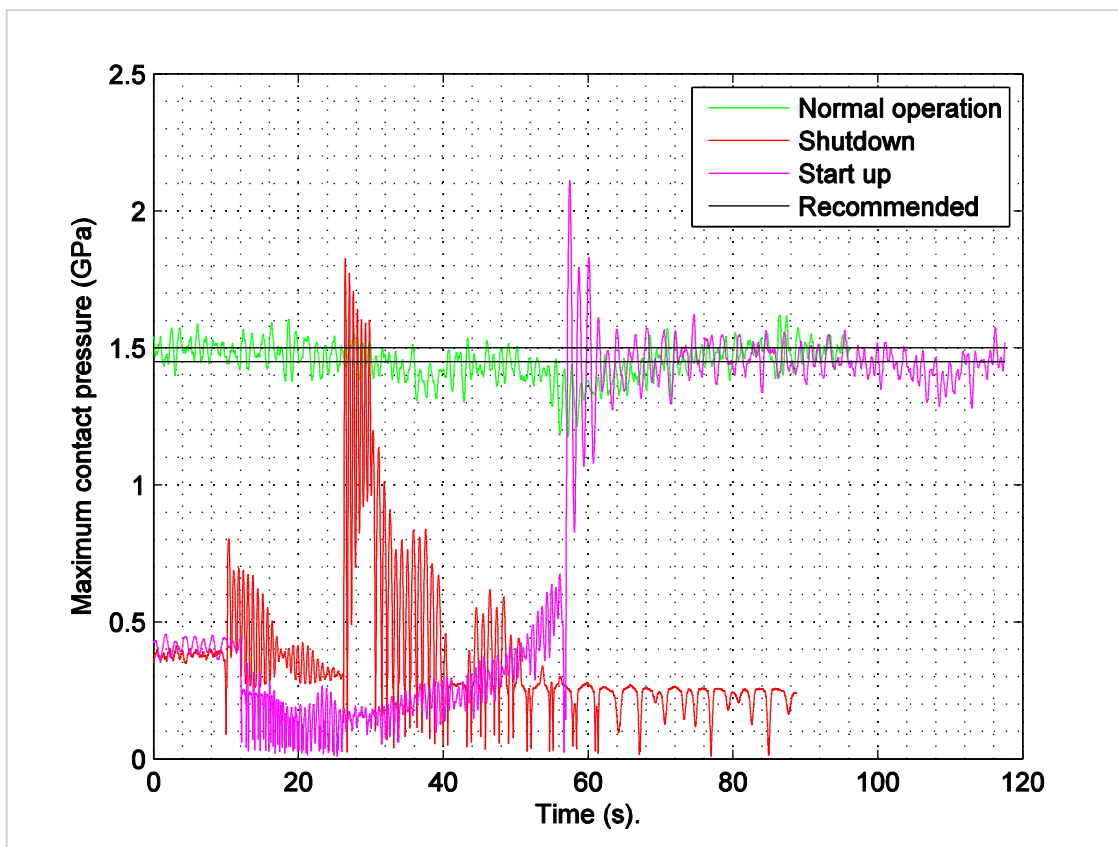
In this study, the 750 kW NREL wind turbine is used to calculate the load and stresses induced on the bearing. The maximum contact pressure on the inner raceway of the planetary bearing during different operational conditions can be seen in Figure 5. These results show that the maximum contact pressure exceeds the

maximum contact pressure recommended in the design standards [30] and [31]. However, this contact pressure will not cause a subsurface yielding of the through hardened bearing steel if the effect of inclusions and gaps is neglected. It is generally assumed that bearings working under lubricated condition are exposed to low traction force. Nevertheless, during the transient events a very low lubricant film thickness, relative to the bearing surface roughness, could occur that elevates the traction

Figure 5: Maximum contact pressure at the inner ring of planetary bearing

3. Load and contact pressure calculation showed higher level than the recommended values. However, the subsurface maximum shear stress at the highest load during transient events is still less than the yielding value. This highlights the effect of gaps, separation, in concentrating and increasing the stress to the critical damaging level in the form of WEA or micro cracks.

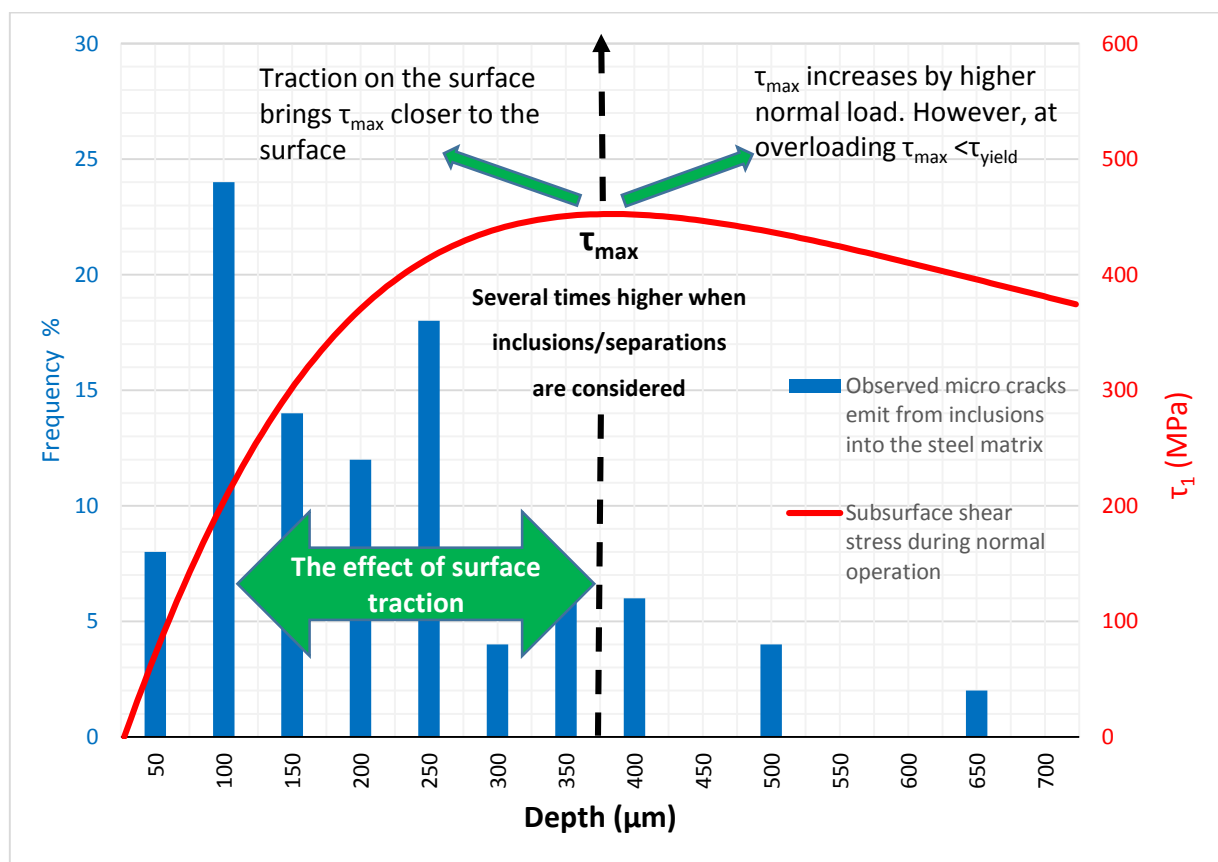
force. This surface traction results in additional subsurface stress and brings the location of the maximum shear stress closer to the surface. It has been found that the maximum shear stress, from the calculations of the subsurface stresses, is located deeper than the dominated depth of the micro cracks, from the failed bearing examination as shown in Figure 6. This shows the significant effect of the surface traction on the subsurface initiated damage.

Figure 6: Depth of micro cracks comparing with depth of subsurface maximum shear stress

4. Correlating the depth of the subsurface damage of micro cracks on the MnS inclusions to the depth of the maximum shear stress revealed the occurrence of considerable surface traction. The surface traction brings the location of the maximum shear stress, potentially subsurface damage location, closer to the contact surface.
