Investigation of wind turbine gearbox bearing subsurface damage considering transient loading and the separation of MnS inclusion

H. Al-Tameemi¹ and H. Long²

Department of Mechanical Engineering, The University of Sheffield, United Kingdom

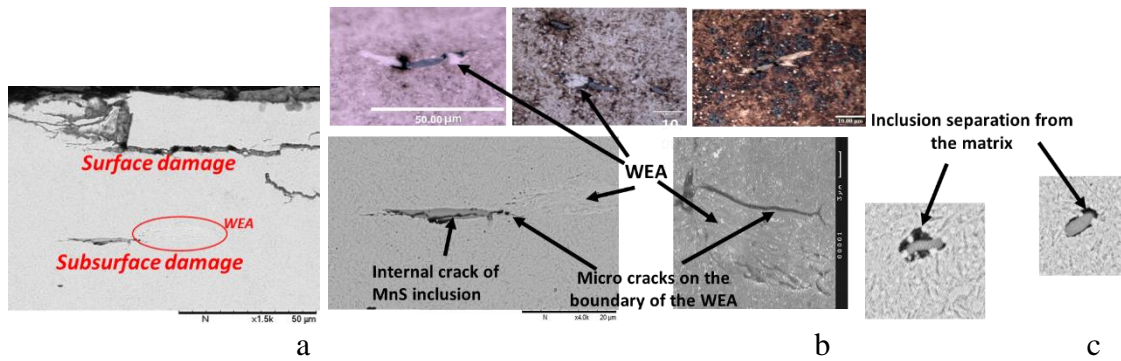
The observed damages varies between surface and subsurface as in Figure 1 (a). This study focuses on the subsurface initiated damages marked in Figure 1 (b) and (c). The character specifications of the inclusions include the length, width, inclination angle with the rolling direction and depth from the surface. The observations are classified into five types which are undamaged inclusions, inclusions separate from the matrix by gap(s), internal cracks of the inclusions, external cracks into the matrix, White Etching Area (WEA) around the inclusion (Butterflies). Statistical study for the characters specified for the inclusions associated with each specified damage type is carried out. This study results in the range and the dominated depth for each damage feature as well as the possible combination of damages. The focus on the MnS inclusion in the literature is less reported than the harder inclusions such as Al_2O_3 because it is assumed that the MnS always deformed without causing gaps attached to it. However, in this study, the results of the EDX and the AFM evidence show that this is not always the case. Moreover, the internal cracking of this type of inclusions is not highlighted before which is investigated here and it is observed to be associated with other kinds of subsurface damages.

Figure 1: Surface and subsurface damages in the failed wind turbine bearing

Because the MnS inclusion separation from the matrix has been observed at different levels of depth to the contact surface, sometimes far from the load zone, it could be considered that the material defect is caused by the different coefficient of thermal expansion [3]. However, other kind of separation could be caused by impact loading [4]. The non-perfect bonding, separation, of the MnS inclusion results in high stress concentration around the inclusion [5]. Accordingly, local yielding occurs in the form of WEA. This explains the association of high percentage of the observed WEA, butterflies, with the separated inclusions. The experimental results from the examined failed bearing from the field emphasize the effect of tangential traction on the subsurface damage of the wind turbine gearbox bearings.

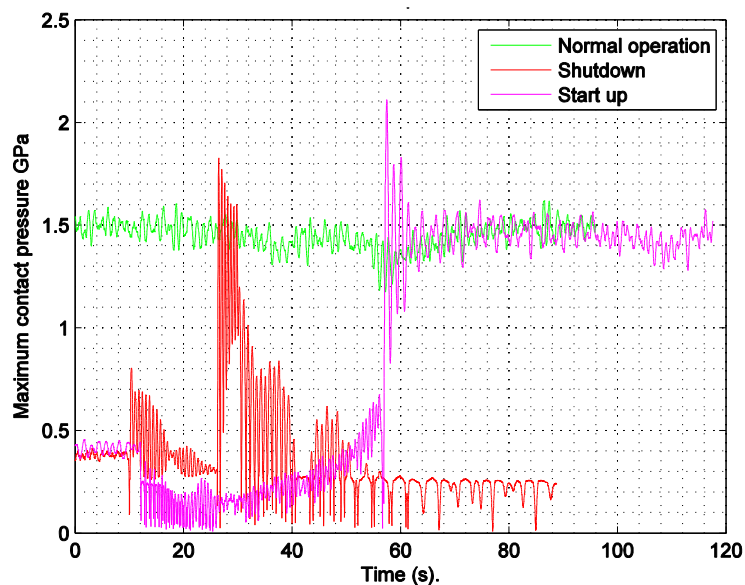
The results of the loading and contact pressure on the inner raceway of the planetary bearing during different operational conditions can be seen in Figure 2. These results show that the maximum contact pressure exceeds the maximum contact pressure recommended according to [1] and [2]. However, this contact pressure will not cause a subsurface yielding of the through hardened bearing steel if the effect of the inclusion and gaps is neglected. It is generally assumed that bearings working under lubricated condition are exposed to low traction force. Nevertheless, during the transient events it has been found that the condition of a very low lubricant film thickness, relative to the bearing roughness, could occur that elevates the traction force. This high traction results in additional subsurface stress and brings the location of the maximum shear stress closer to the surface. It has been found that the maximum shear stress, from the calculations of the subsurface stresses, is located deeper than the dominated depth of the micro cracks, from the failed bearing examination. This shows the important effect of the surface traction.

Figure 2: The maximum contact pressure on the planetary bearings
