# A Study on Vibration Signals of Wind Turbine through the Condition Monitoring System

A study on wind turbine vibration signals caught by Condition Monitoring System, CMS, was carried out in Gasi wind farm of Jeju Island, South Korea. The vibration signal with 10khz was measured by strain gages which were installed on the gearbox of wind turbine for two months from February to April, 2016. The time domain analysis was performed with the data above 50 % of the sampling rate. The vibration data were processed with band pass filter to clearly detect the wind turbine faults. The frequency domain analysis was also performed using enveloping technique to find turbine faults with low frequency. Fast Fourier Transform, FFT, was applied to the processed vibration data. Defect frequencies of bearings of gearbox were measured in the range from 464hz to 9hz and these acceleration values were lower than the vibration acceptance level of 0.5 m/s<sup>2</sup>. Therefore it could be confirmed that the bearings of the gearbox worked without any failure.

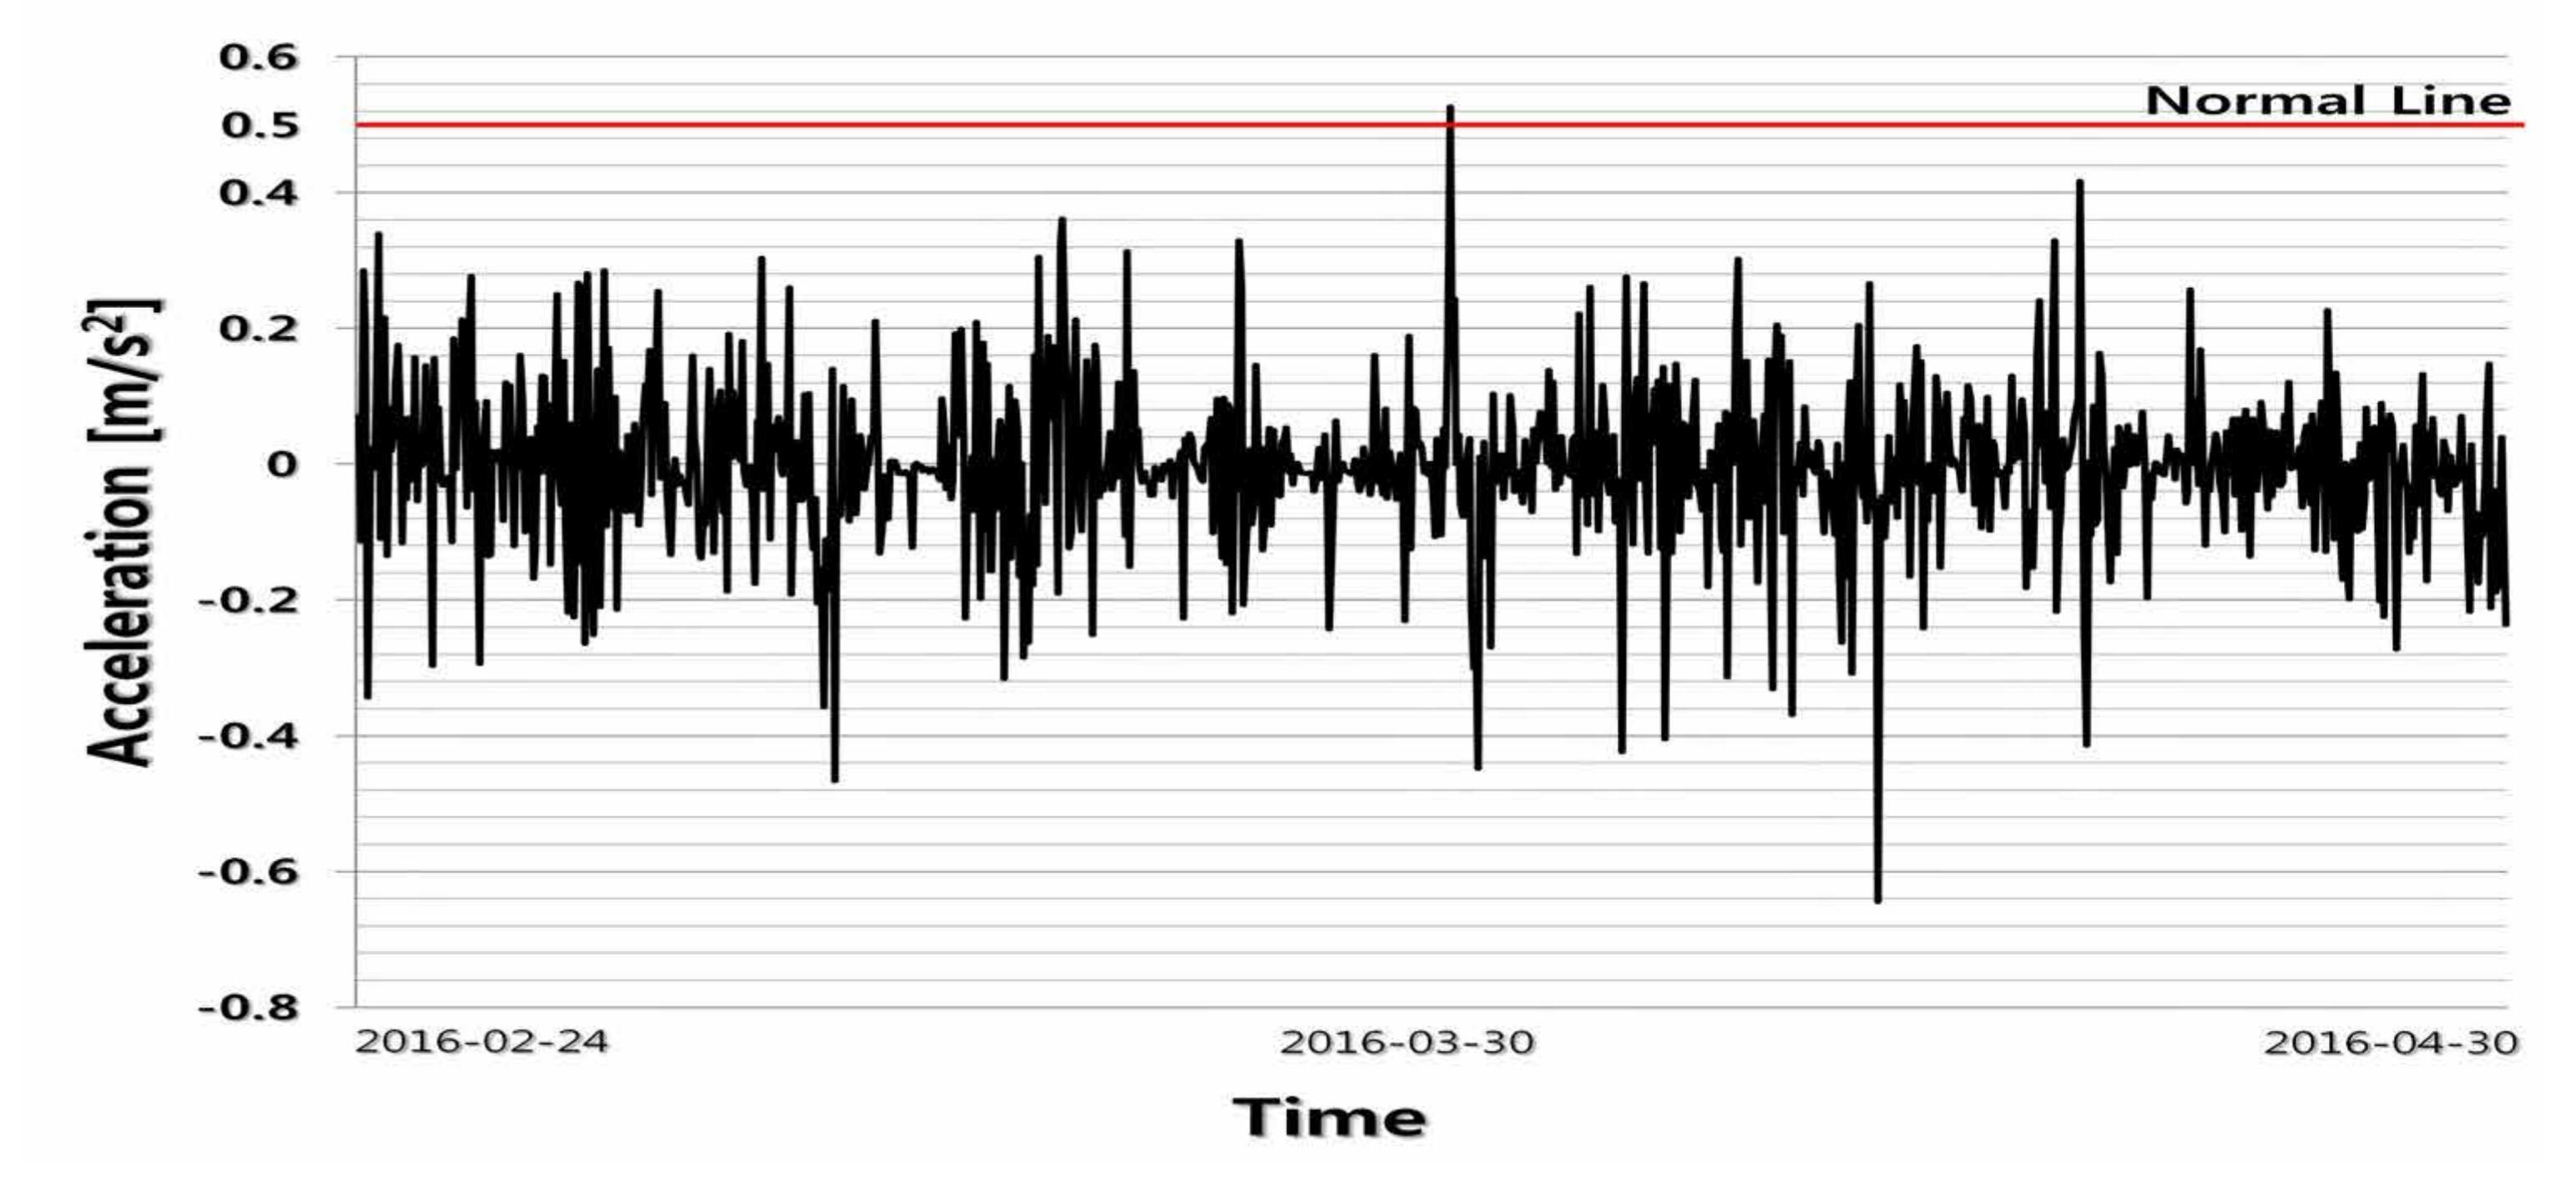
Fig. 4 Trend signal of HSS at gearbox (Normal level : 0.5[m/s<sup>2</sup>], Source: VDI3834)

- Defect frequencies of bearings of gearbox were estimated in the range from 464hz to 9hz and these frequencies were found to be nearly the gear mesh frequency.
- 2. Based on the vibration acceptance level which was suggested by VDI3834 standard, the acceleration values of defect frequency were lower than normal level, 0.5 m/s<sup>2</sup>.

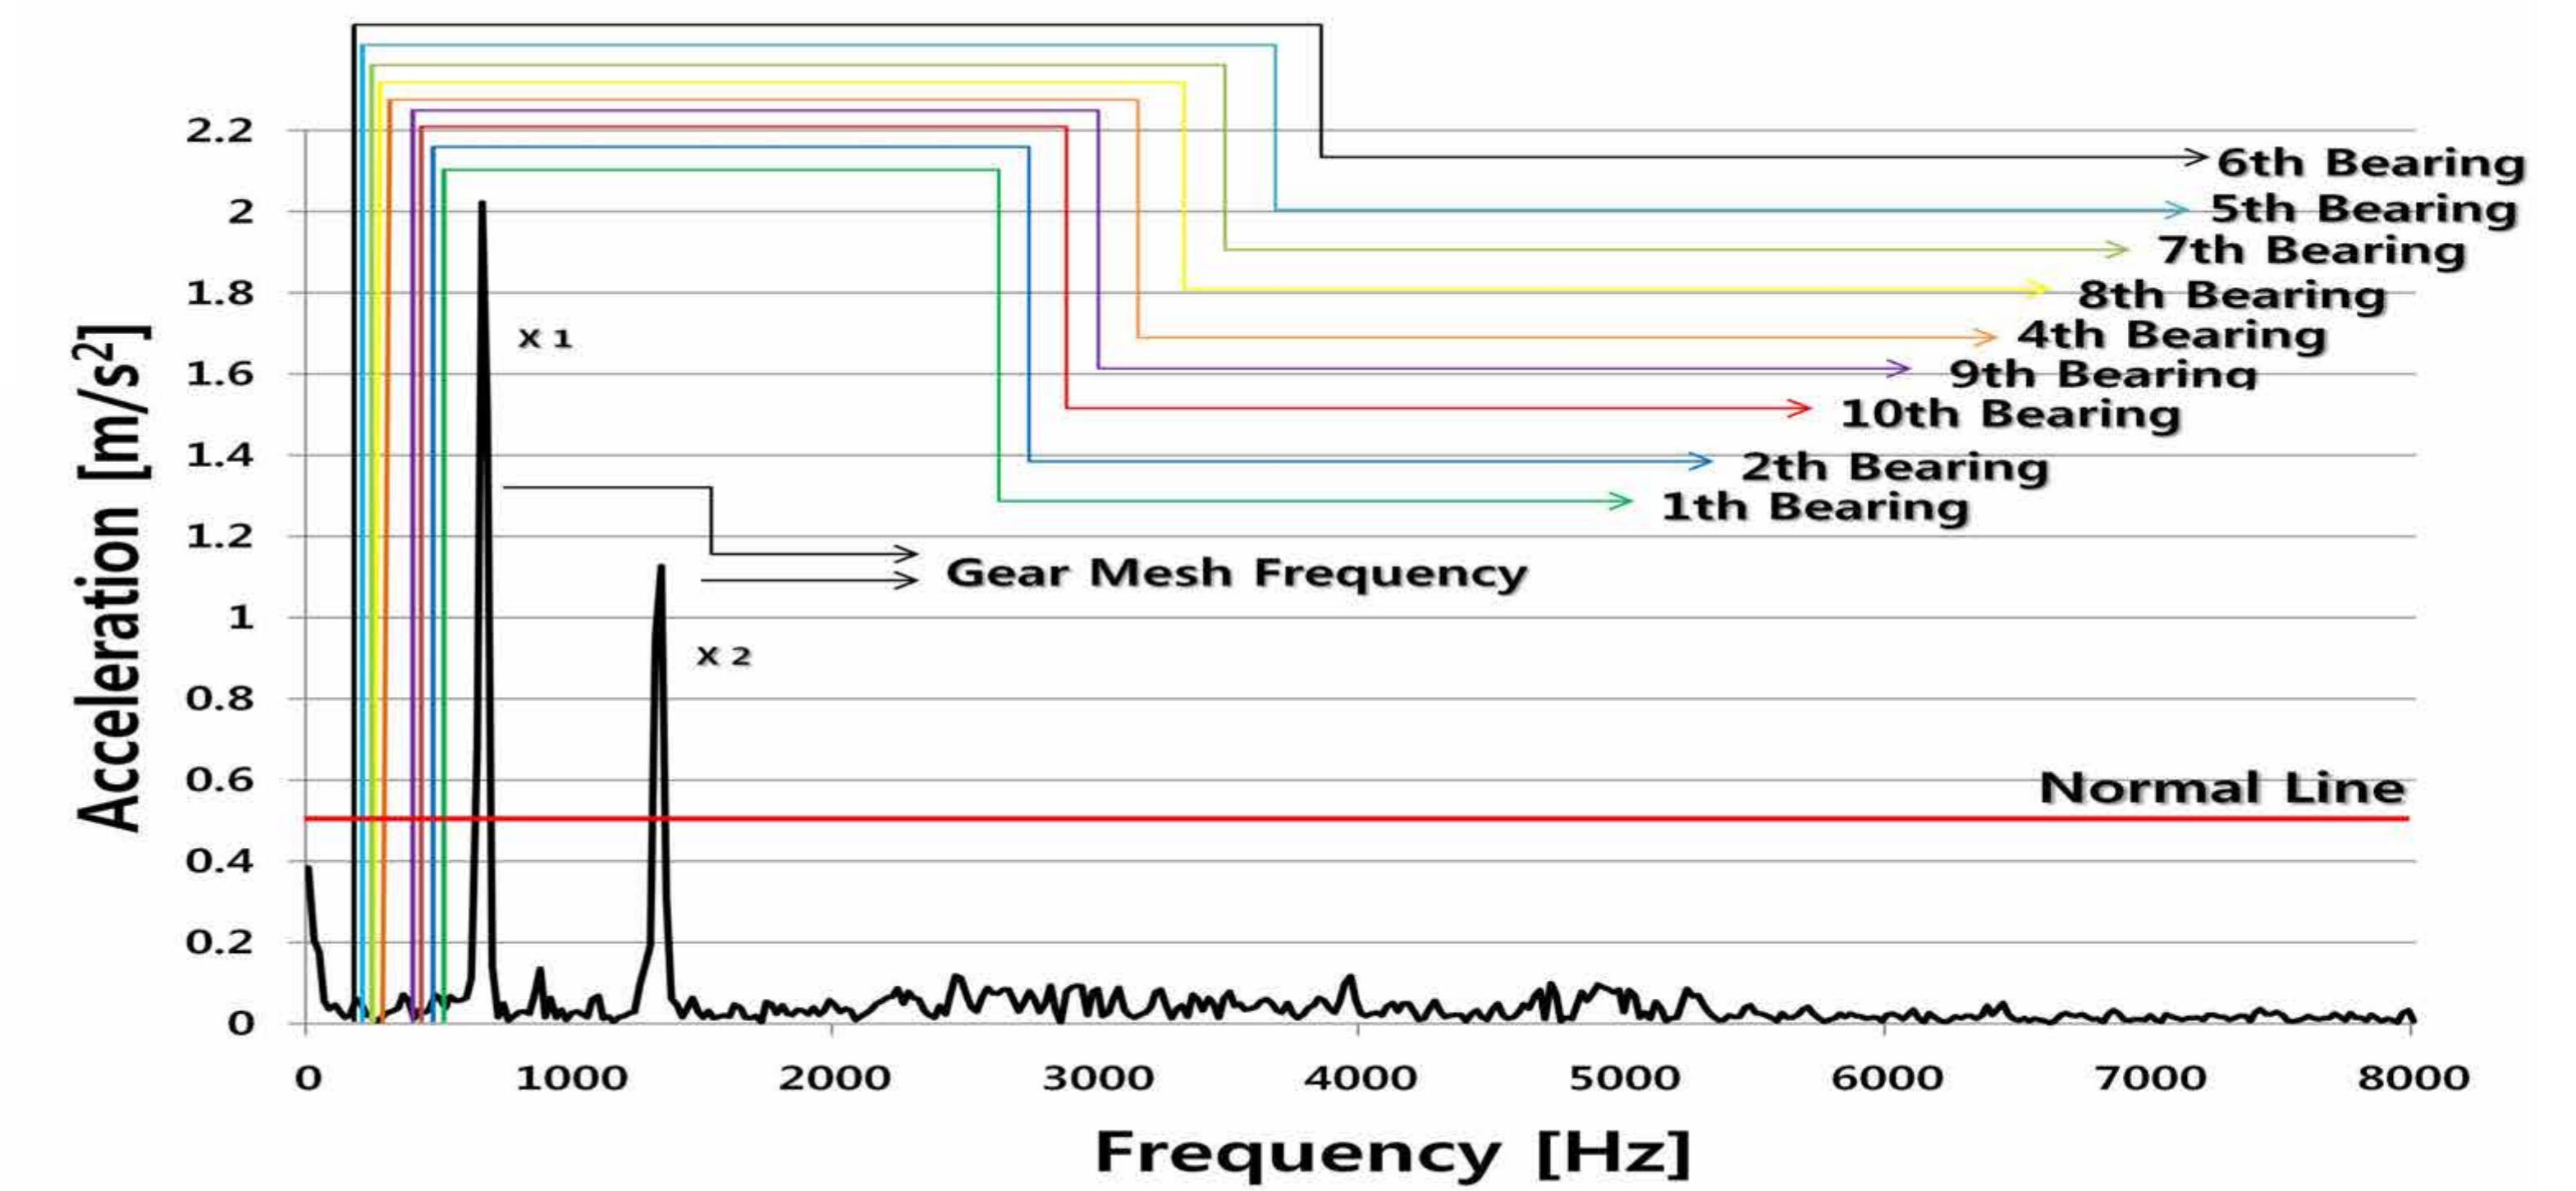
Fig. 5 Frequency spectrum of HSS at gearbox and Defect frequency of bearing inner race (Normal level : 0.5[m/s<sup>2</sup>], Source: VDI3834)

3. It was estimated that vibration behavior of the bearings was within the range of normal operation, which led to the conclusion that there were not any defects for the bearings.
