# New technologies for wind turbines foundation repair

PO.078d

Alberto Gonzalo - Dr. Ingeniero de Caminos  
[alberto@hcc-es.com](mailto:alberto@hcc-es.com)

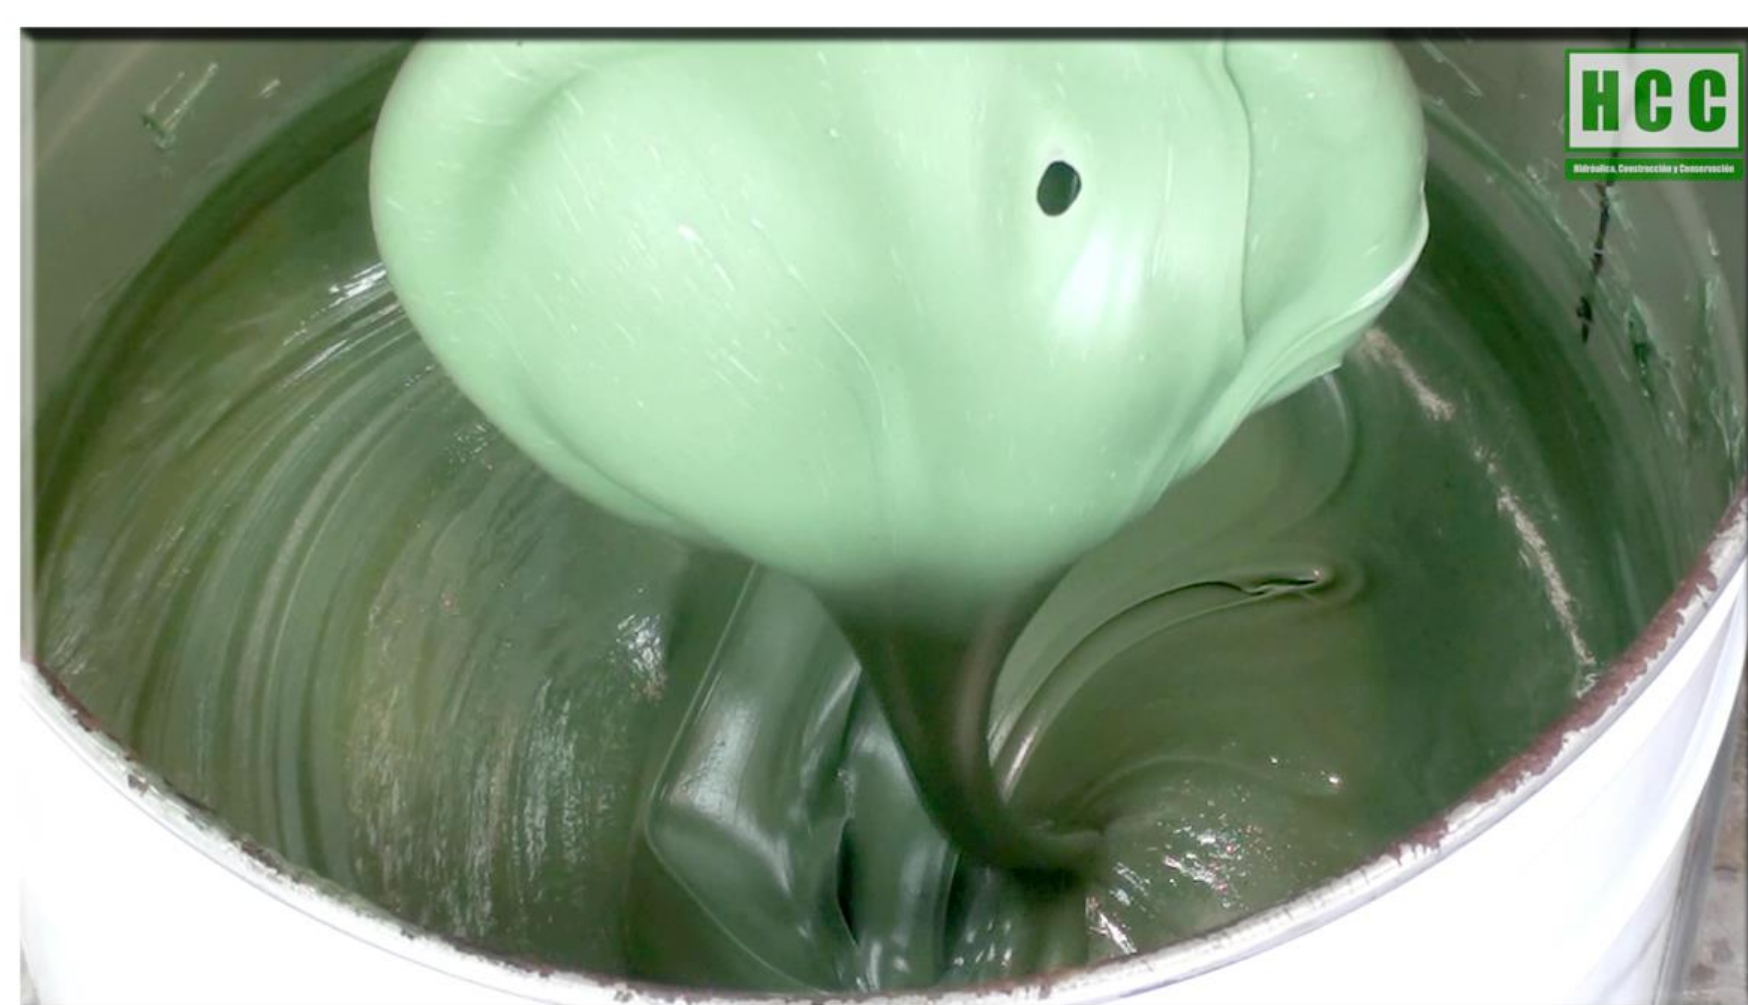
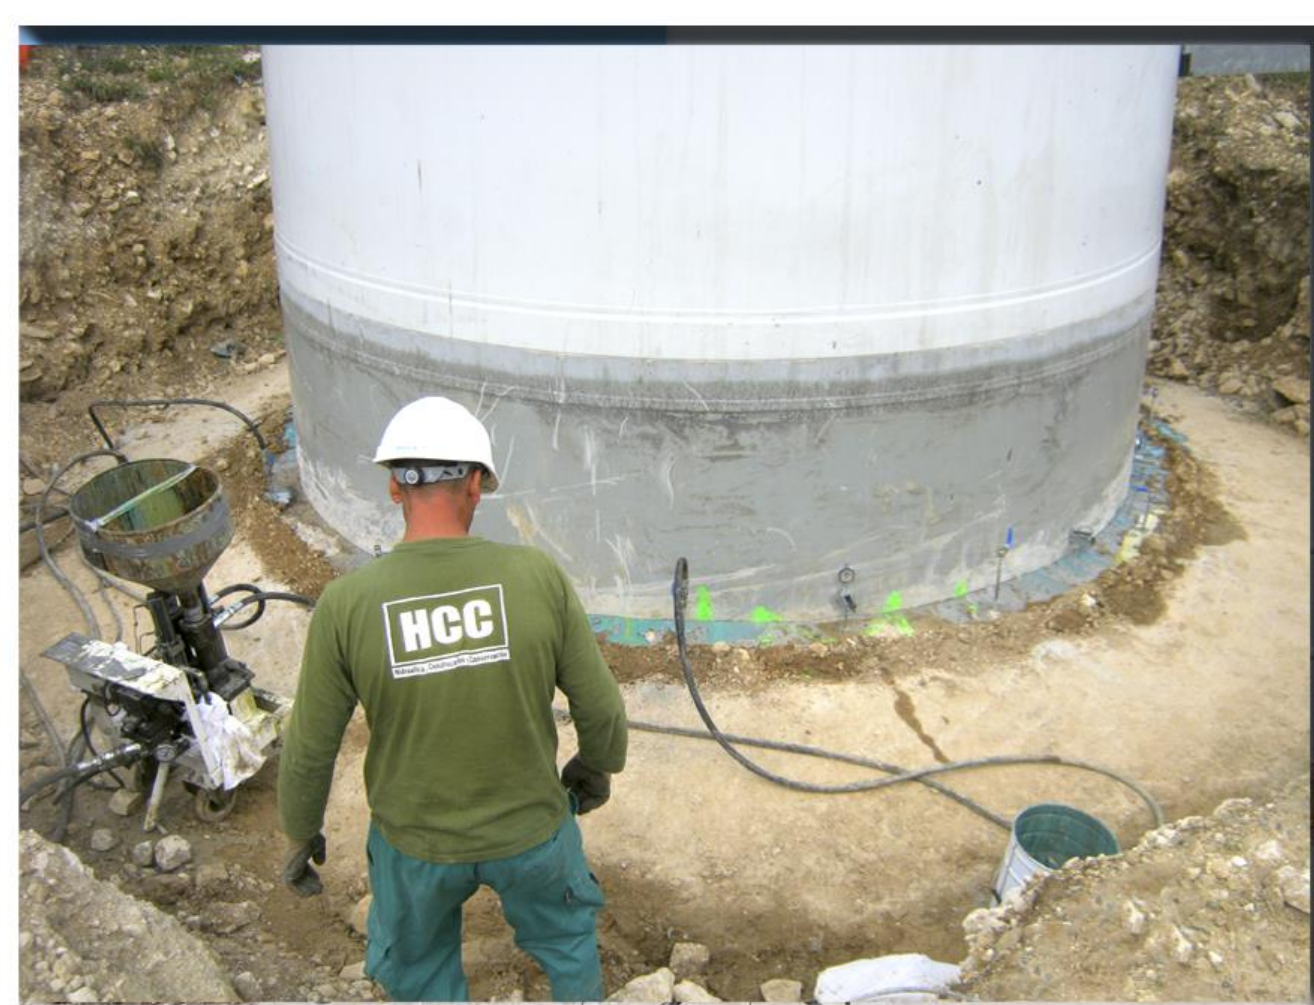
The technology is based on the use of very high viscosity resins, specially formulated, injected at very high pressure. Viscosities up to 1.000.000 cP and pressures up to 600 atm are used.

The aim was to return the monolithic concrete fractured under the flange and encapsulate the ferrule on its pedestal, with a strong and elastic material, minimizing the movements and ensuring the durability of the repair.

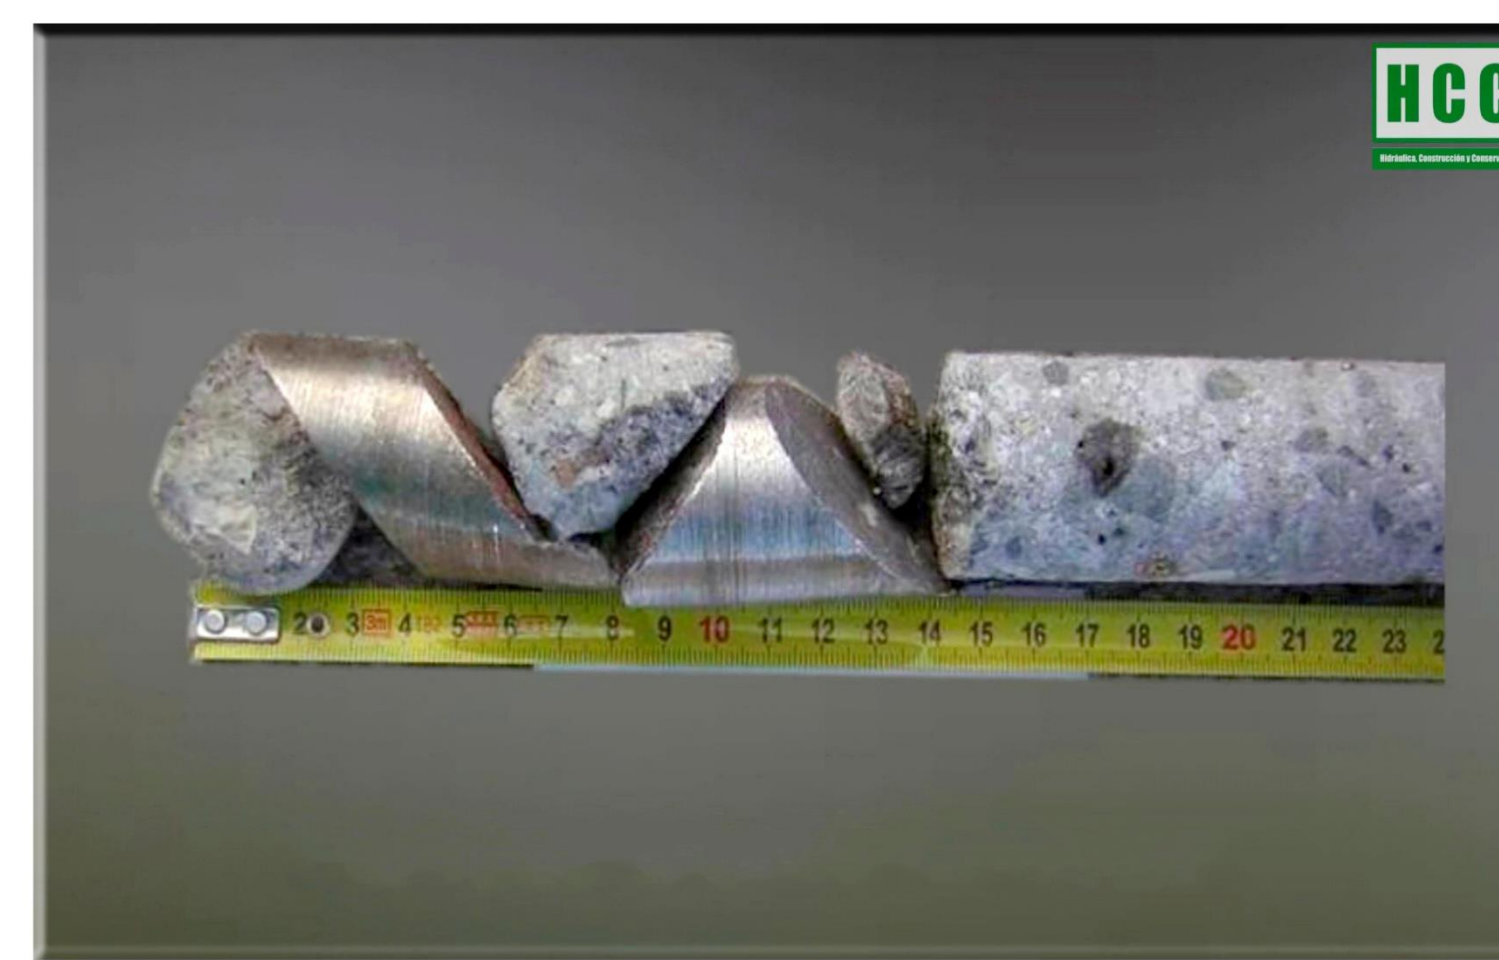
A first qualitative assessment of the effect of the injection is obtained by inspecting the samples extracted from the flange area first, prior to pumping the epoxy resin and secondly, after executing the work.

In the first case, concrete and steel appear to be completely separated.

In the second case, we notice how the resin adheres to the concrete as well as to the steel, constituting a monolithic structure. The injection of highly viscous putty at high pressure allows completely filling in all areas and strengthening the pulverized concrete. It is noticed that the injected areas are several millimetres thick.

Also, it is noticed that the resin rises through the annular space between the ring and the pedestal, through the inner as well as outer area.

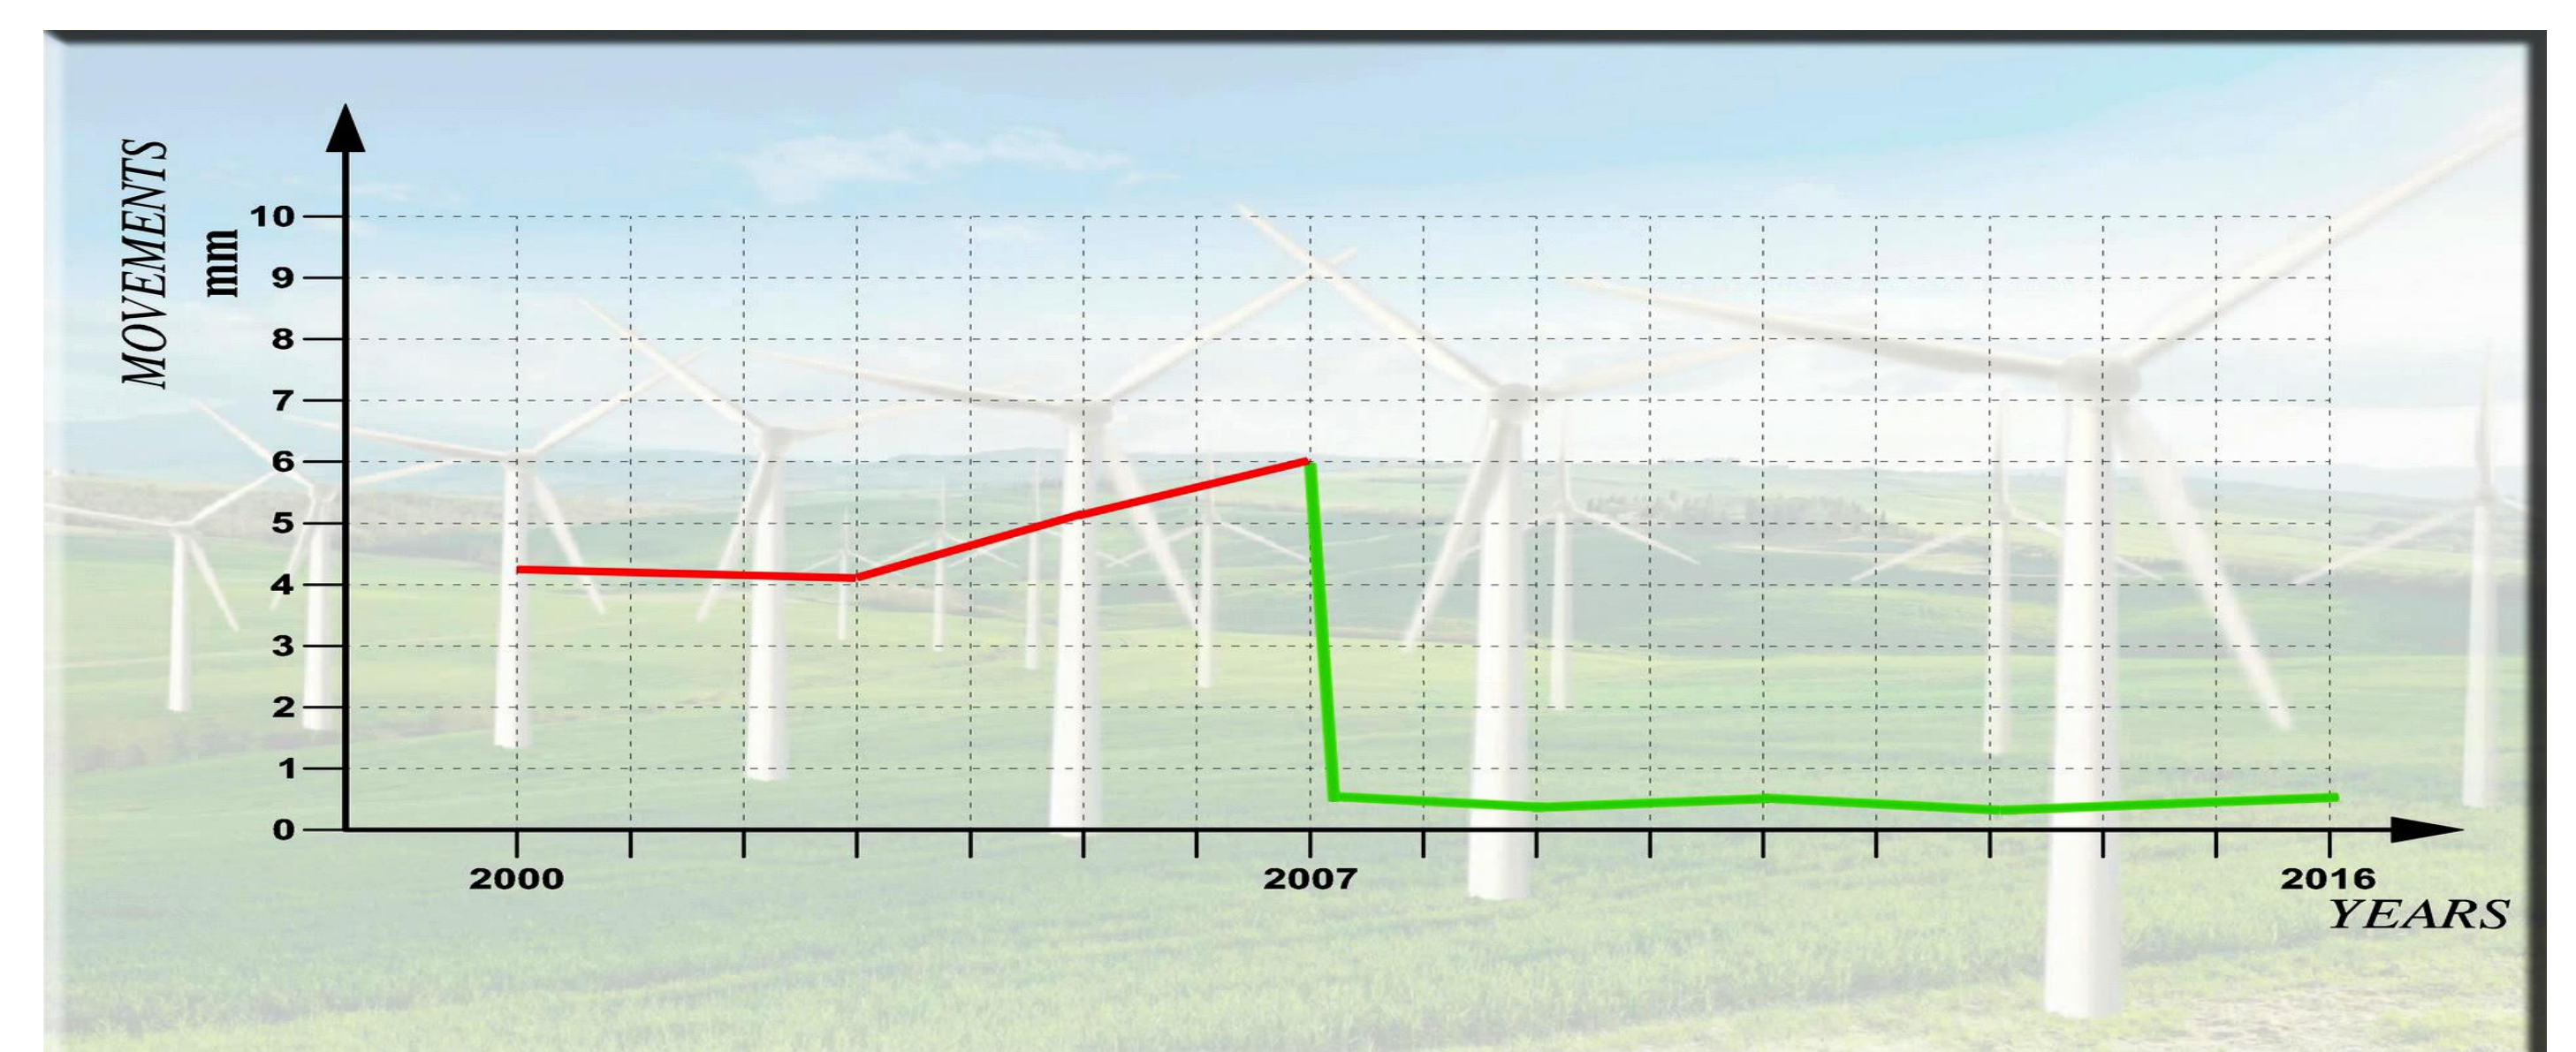
In terms of effectiveness, given the perspective of nine years of experience and **more than 300 foundations repaired** in extreme latitudes of the northern hemisphere, is concluded that the repair technology ensures a stable performance of the foundation. The graph below shows the typical changes in the movements of the turbines before and after the injection of the foundation.
