Investigation of wind turbine gearbox bearing subsurface damage considering transient loading and the separation of MnS inclusions

Wind turbine bearing failure

Destructive investigation of a failed bearing

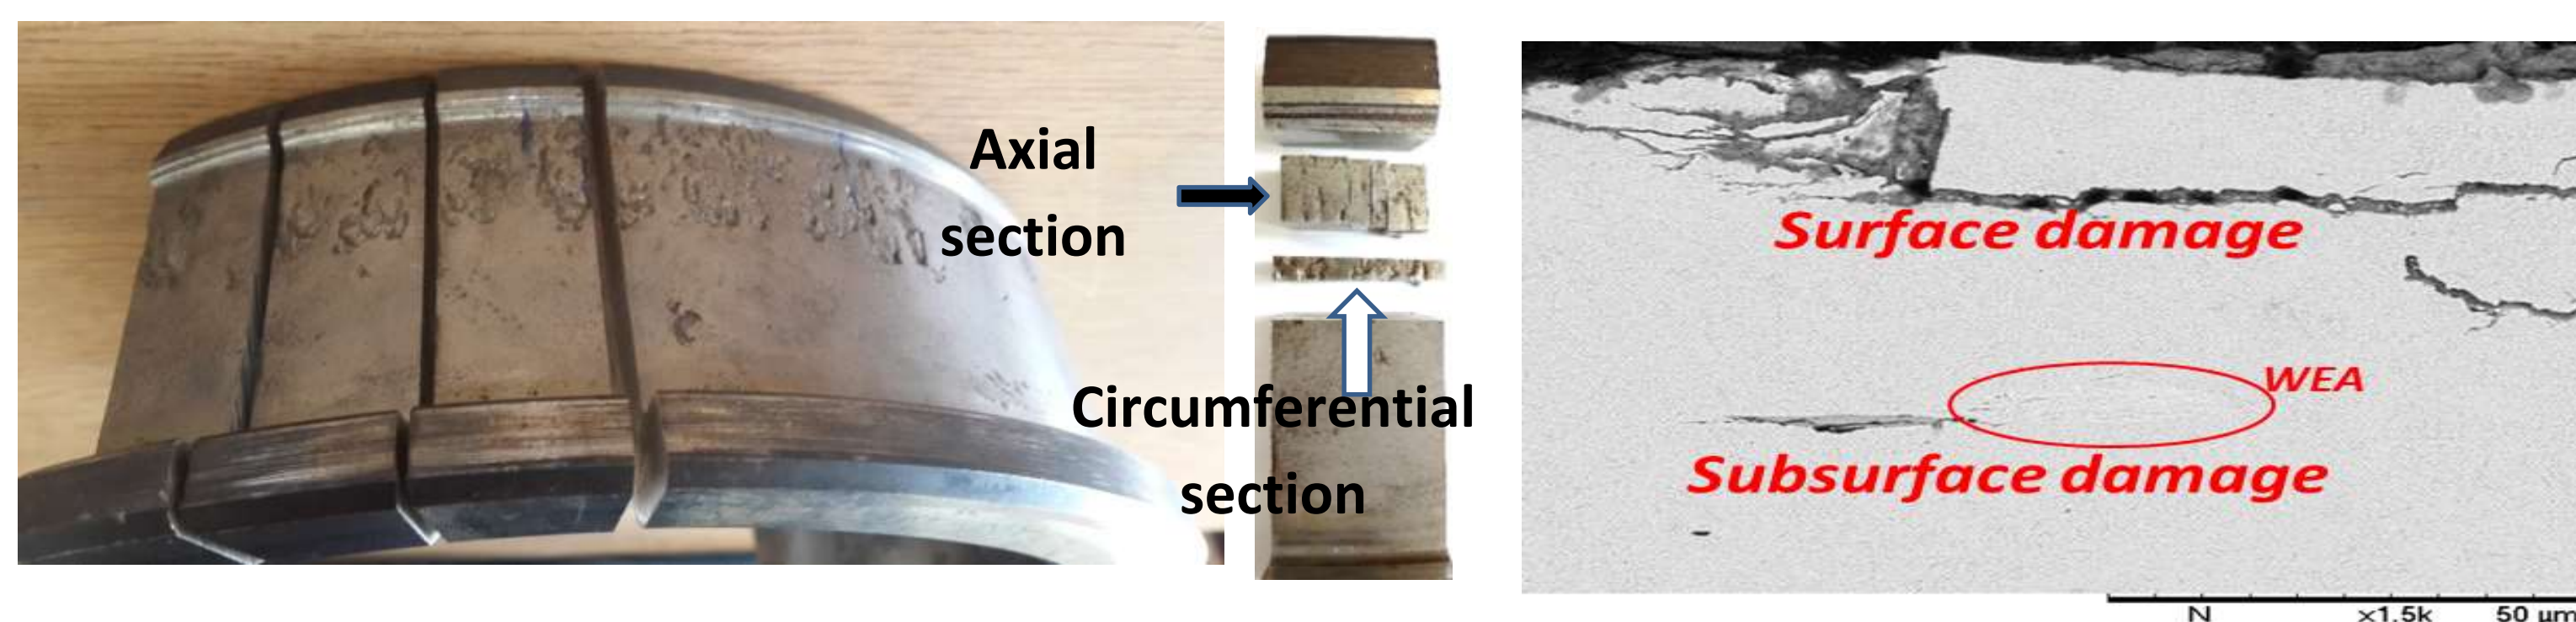
To develop a better understanding of the deterioration of wind turbine bearings during service, an examination of a bearing failed prematurely during the service is performed. It is a sub megawatt WT GB bearing. The microscopic examination of the subsurface area covered more than 1 mm depth from the surface. More than 200 MnS inclusions are observed in different sections.

The failures may initiate either on the surface or near the surface of contact in the bearing raceways. In this study, the examination focused on the subsurface initiated damage of the MnS inclusions and the surrounding steel matrix.

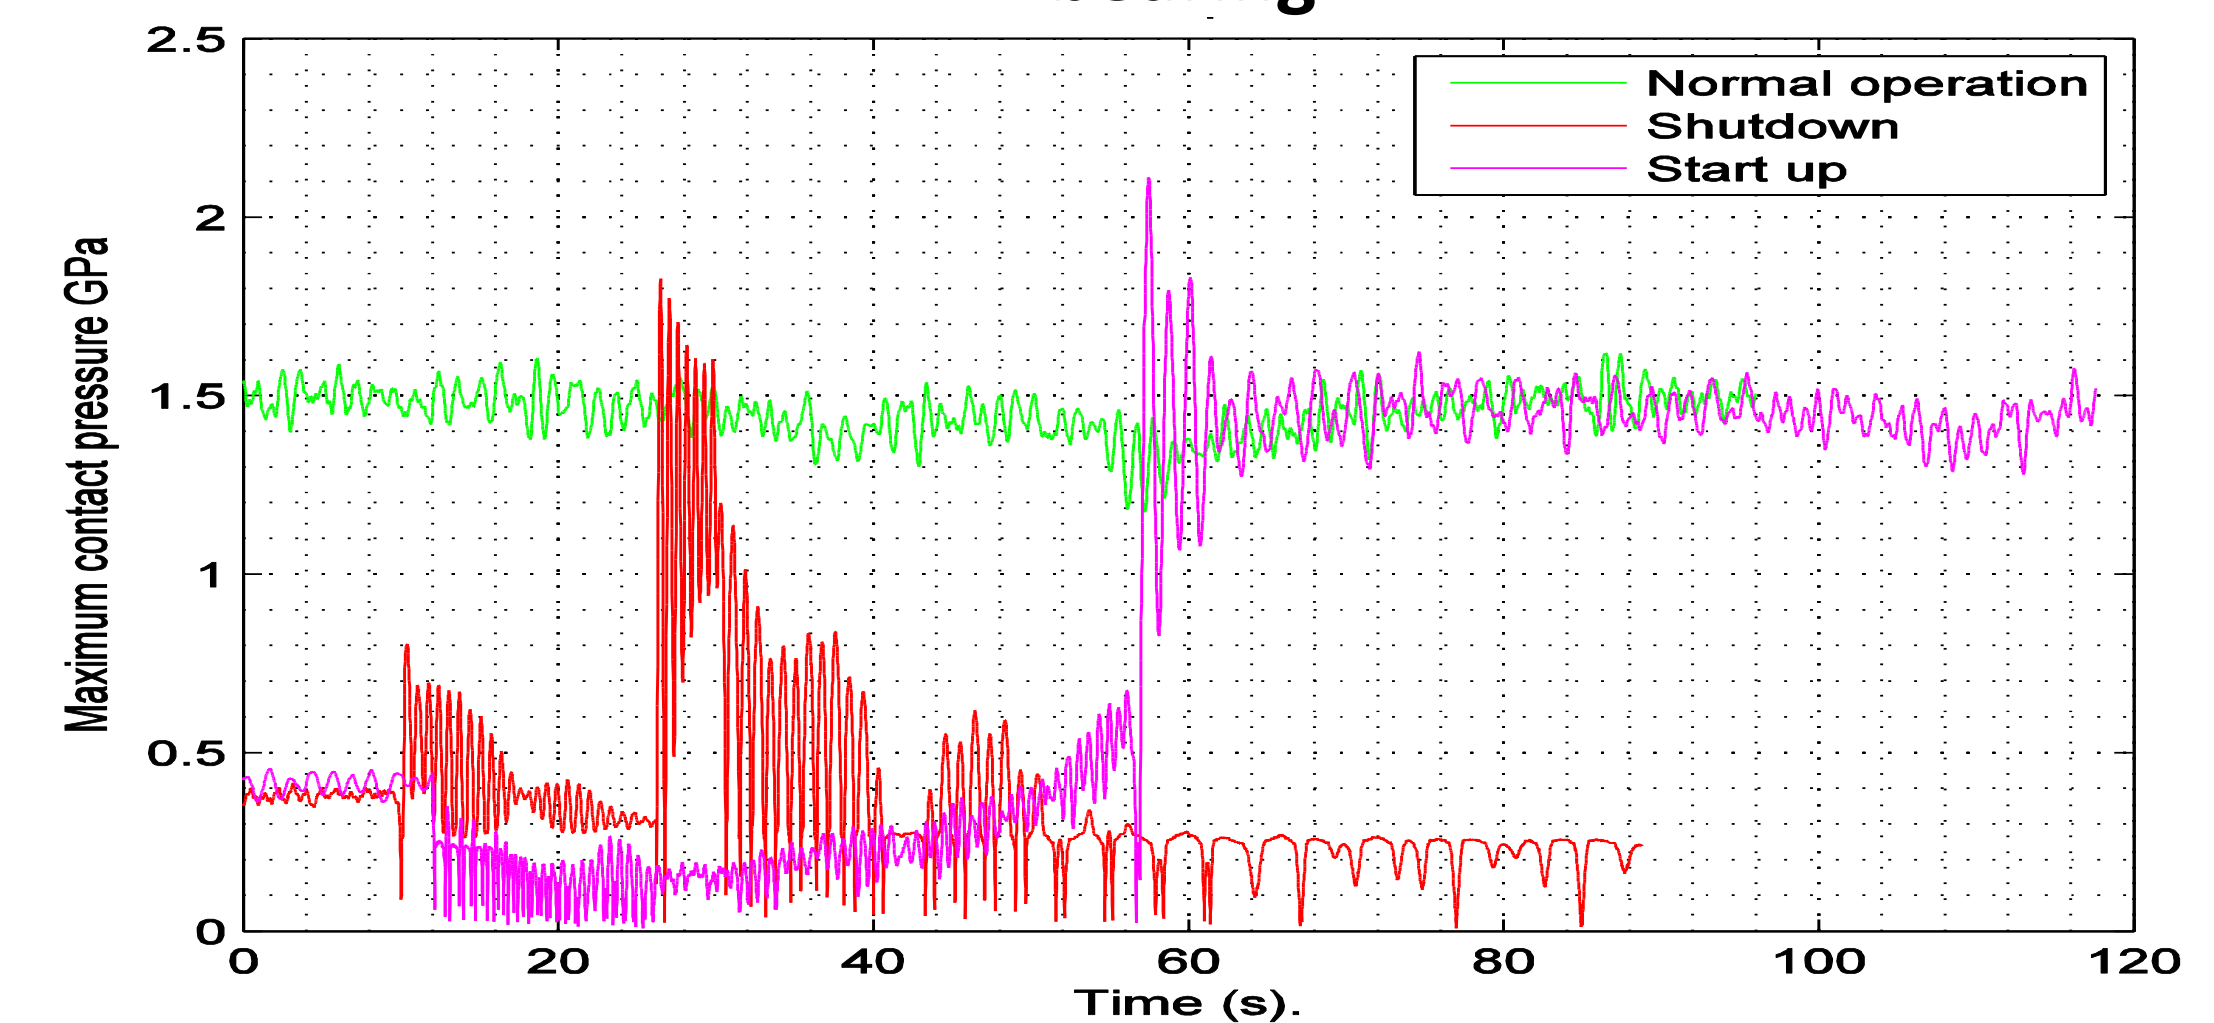
Maximum contact pressure at the inner ring of planetary bearing

The torque and speed measured at the low speed shaft of NREL 750 kW WT are used to calculate the load on each raceway of the planetary bearing. The radial load acting on each planetary bearing is shown in Equations 1.

The radial load on the upwind bearing is calculated assuming 50% more load than the downwind bearing¹. The maximum contact pressure on the inner race is calculated from Equation 2 where Q_0 is the maximum roller-raceway normal load. The maximum subsurface shear stress τ_1 is calculated from Equation 3.
