Comparison of two Nacelle Mounted LiDAR technologies for a wind turbine yaw misalignment analysis

PO.016

Alix PRADEL, Julien DALMAS, Christophe LEPAYSAN
UL DEWI, VALEMO, EPSILINE

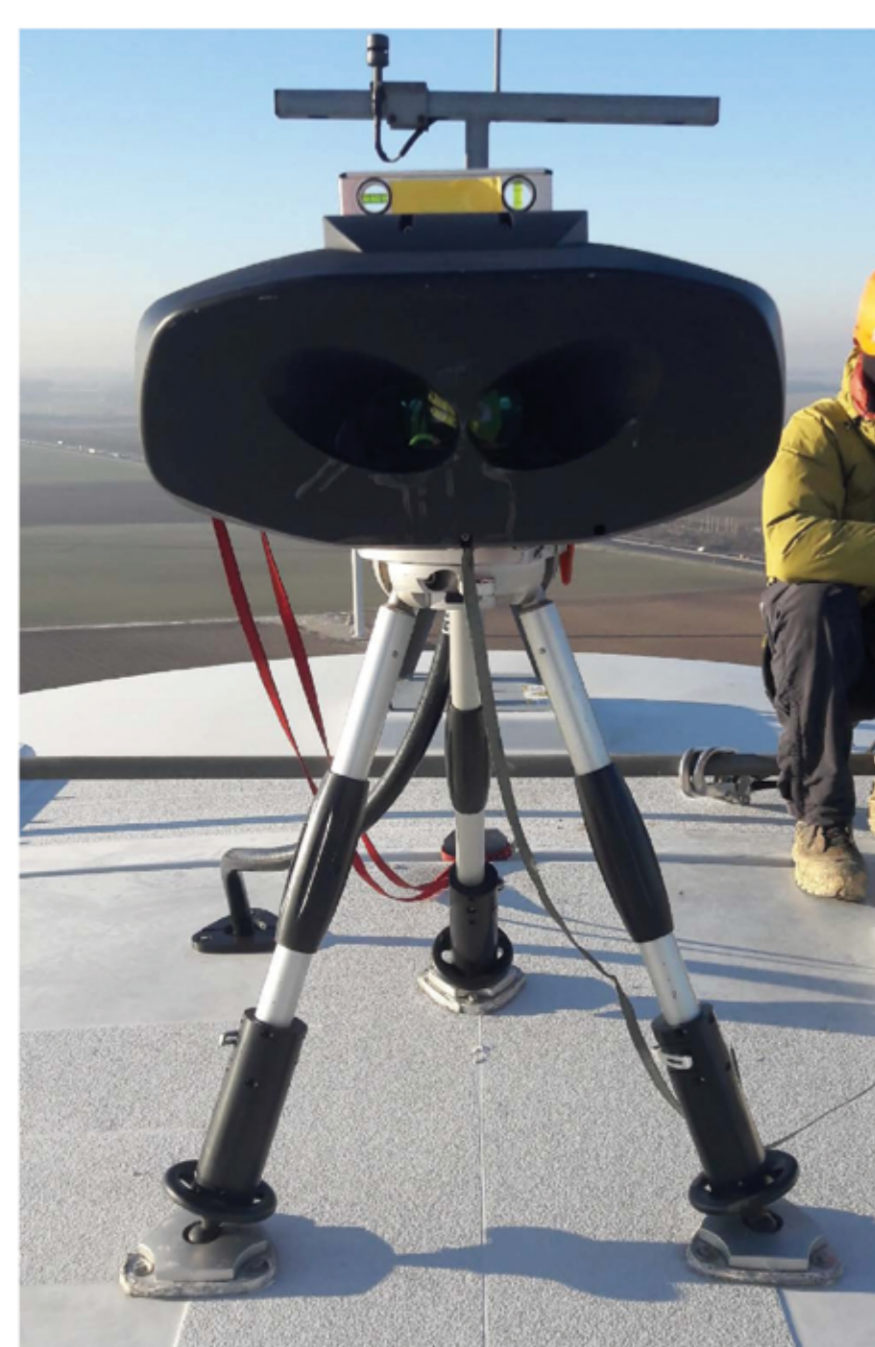
Wind Iris measuring at 80 to 400 m distance

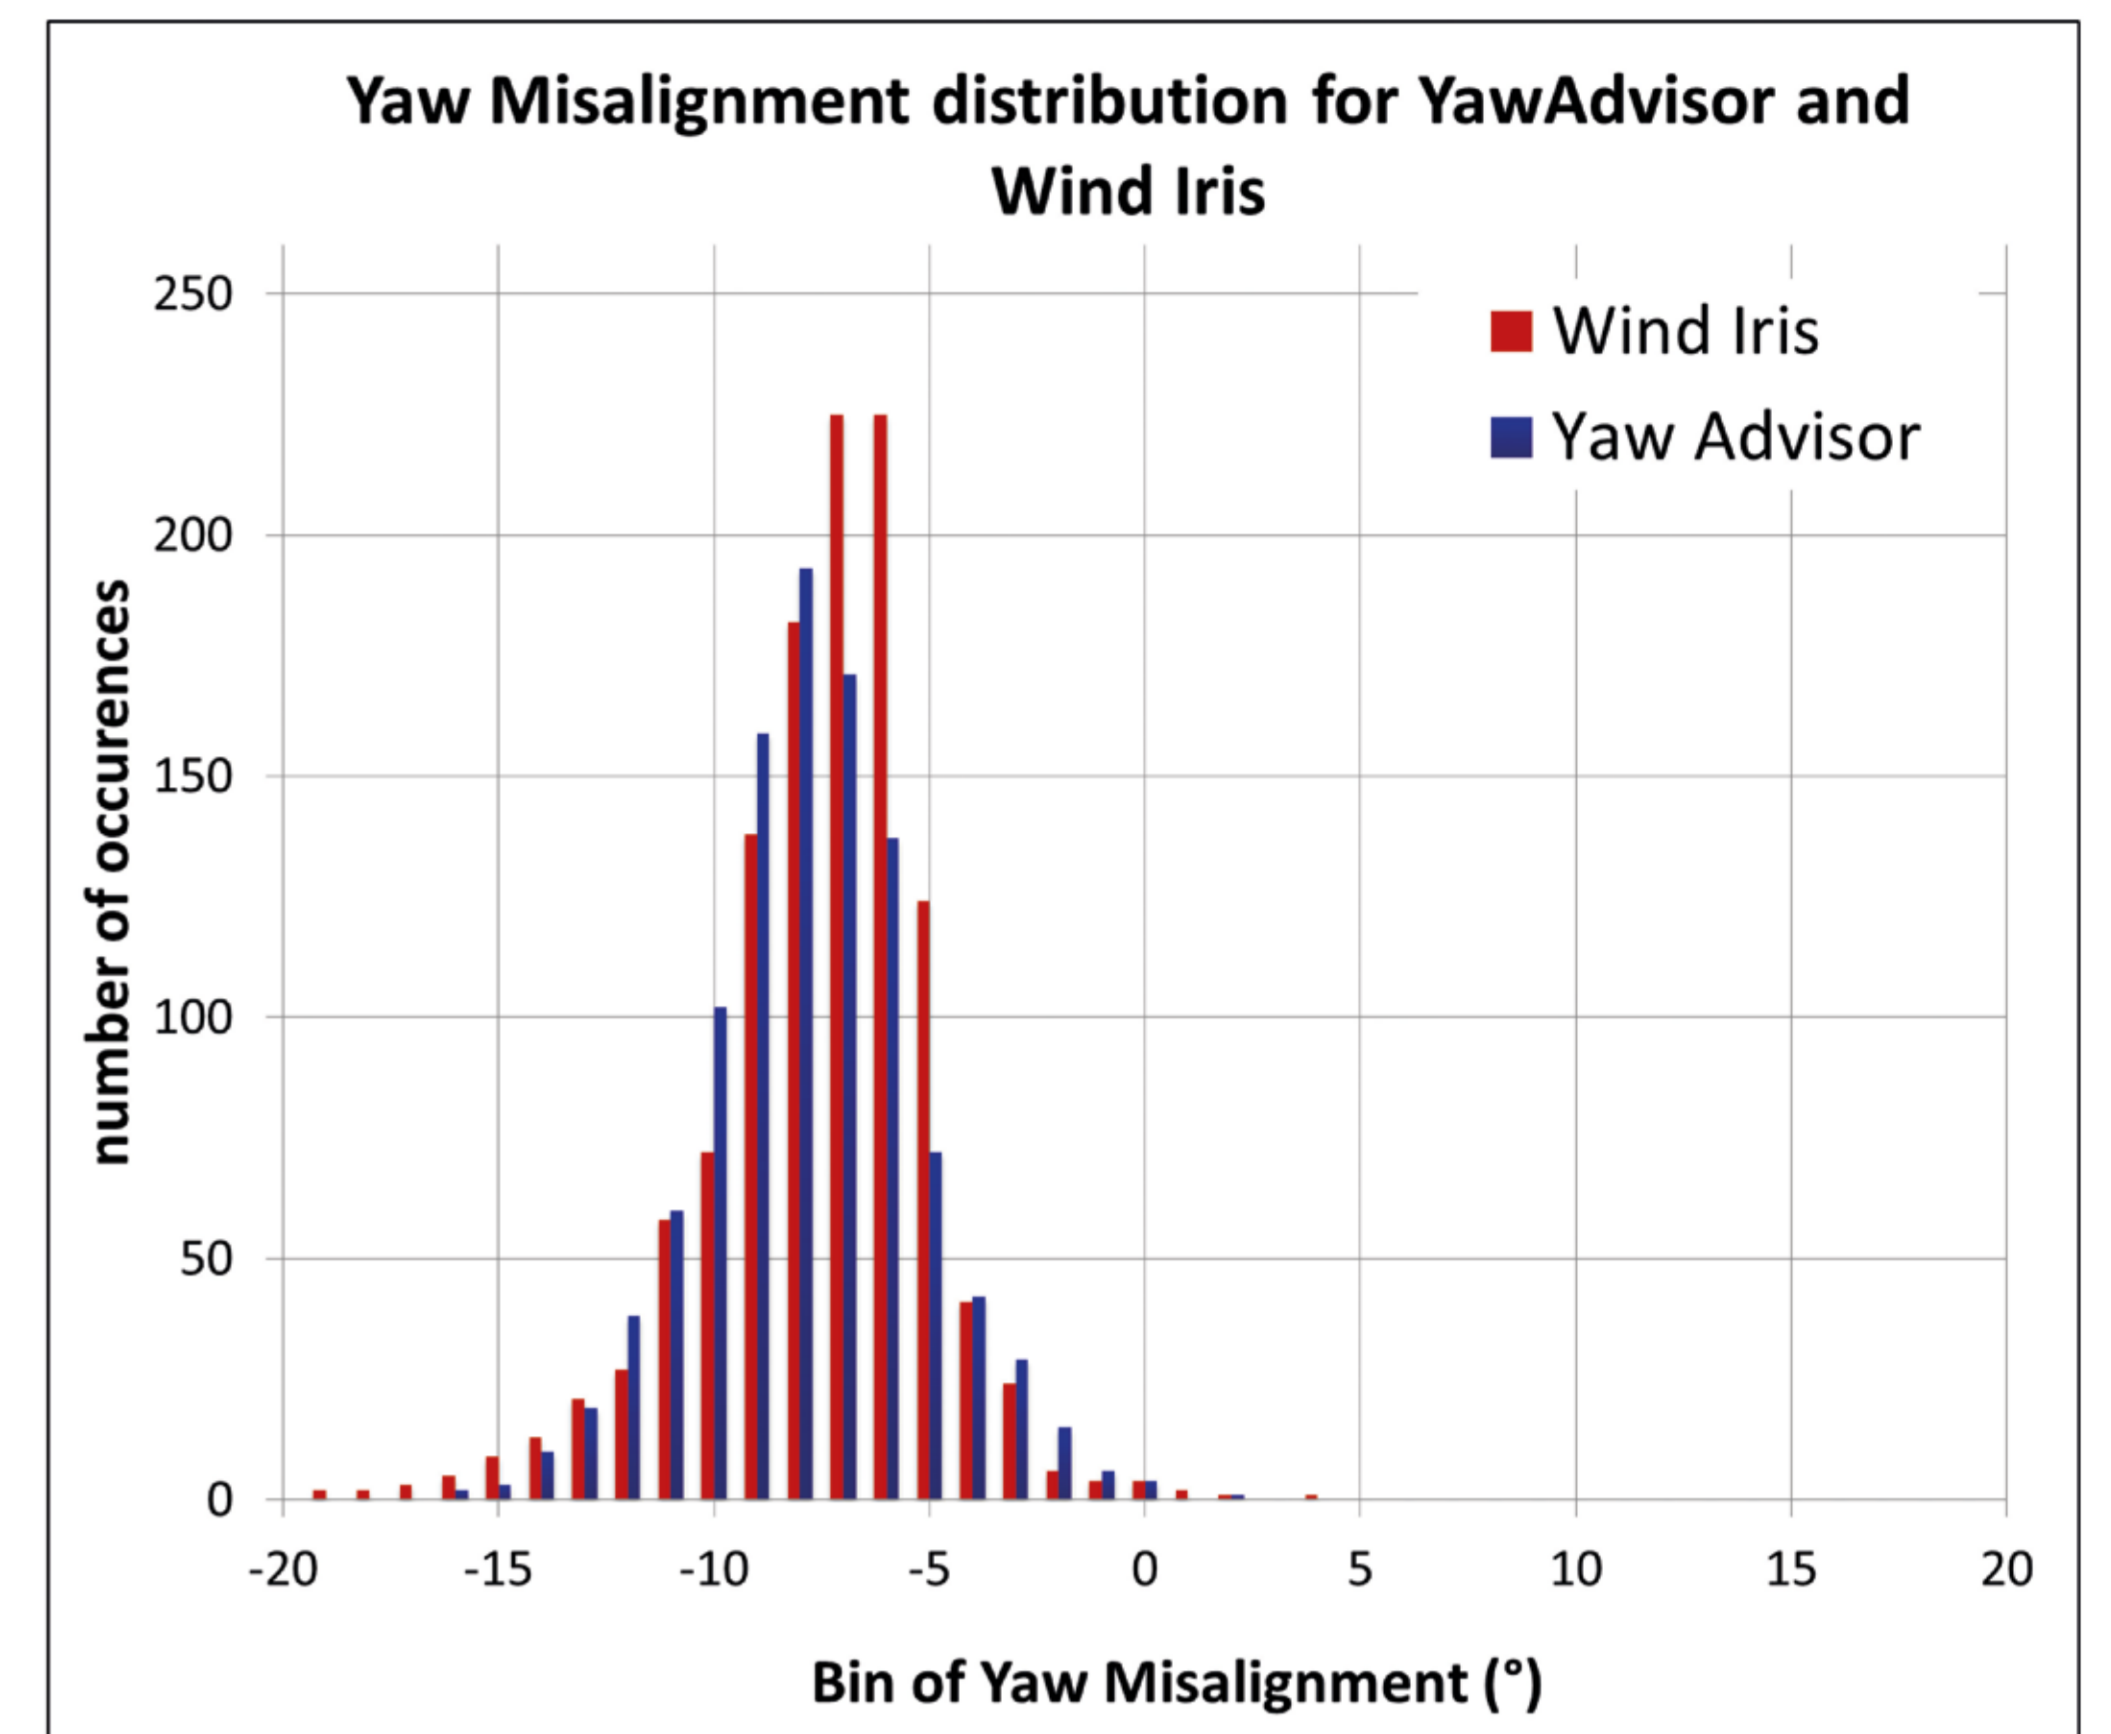
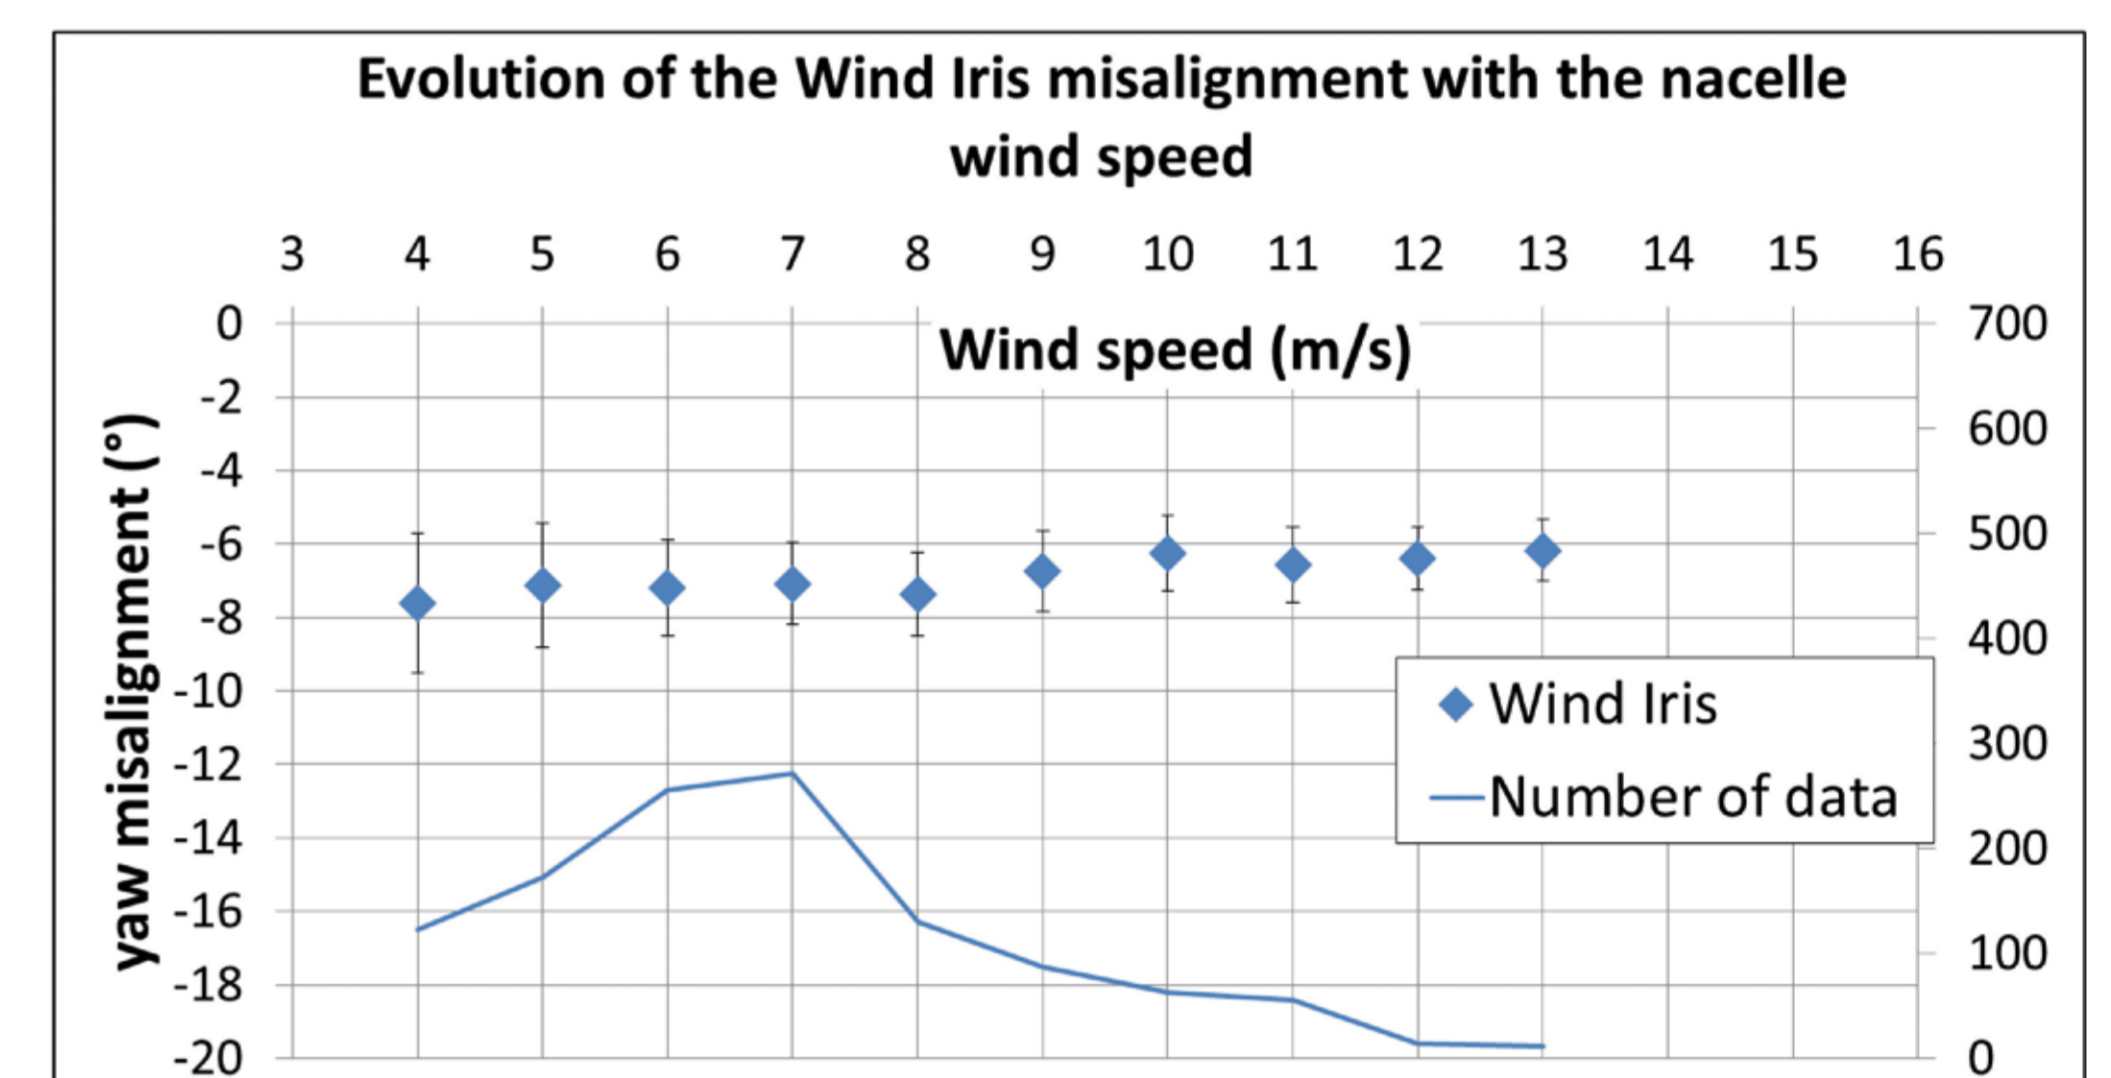
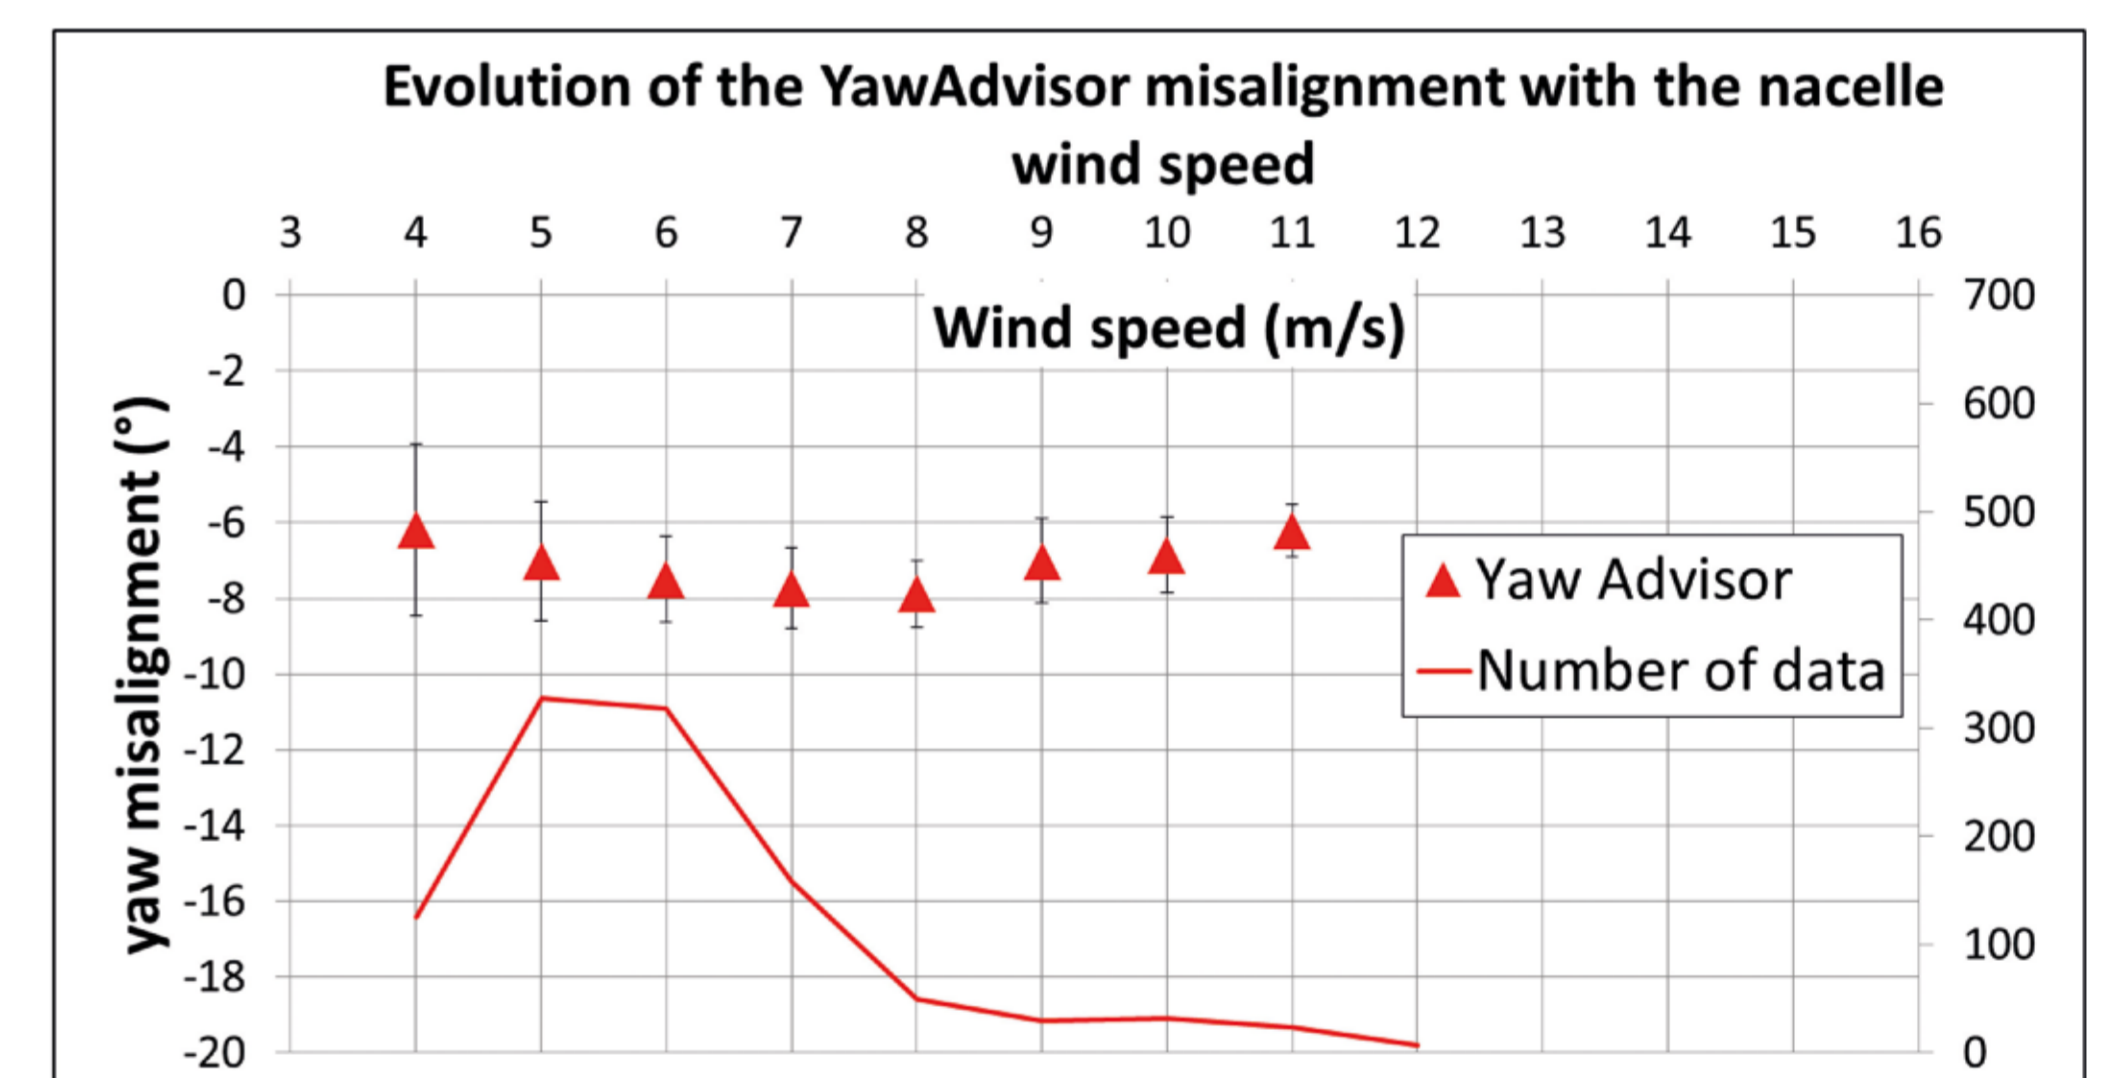
Equipment	Misalignment average value	Standard deviation
YawAdvisor	-7,3°	2,5°
Wind Iris	-7,1°	2,7°

The data gathered by both devices are consistent and it has been concluded that the studied wind turbine was misaligned by approximately -7°.

These results are encouraging as they show that the relative wind direction measured 10 m ahead of the wind turbine is comparable to the relative direction measured at longer distances.
